Form No.: 160.00-M1 LS04	1002
	Supersedes: 160.00-M1 (LS04) (702)	
LITERATURE SUPPLEMENT	File with: 160.00-M1	
Subject: Variable Speed Compressor Serial Communications Faults

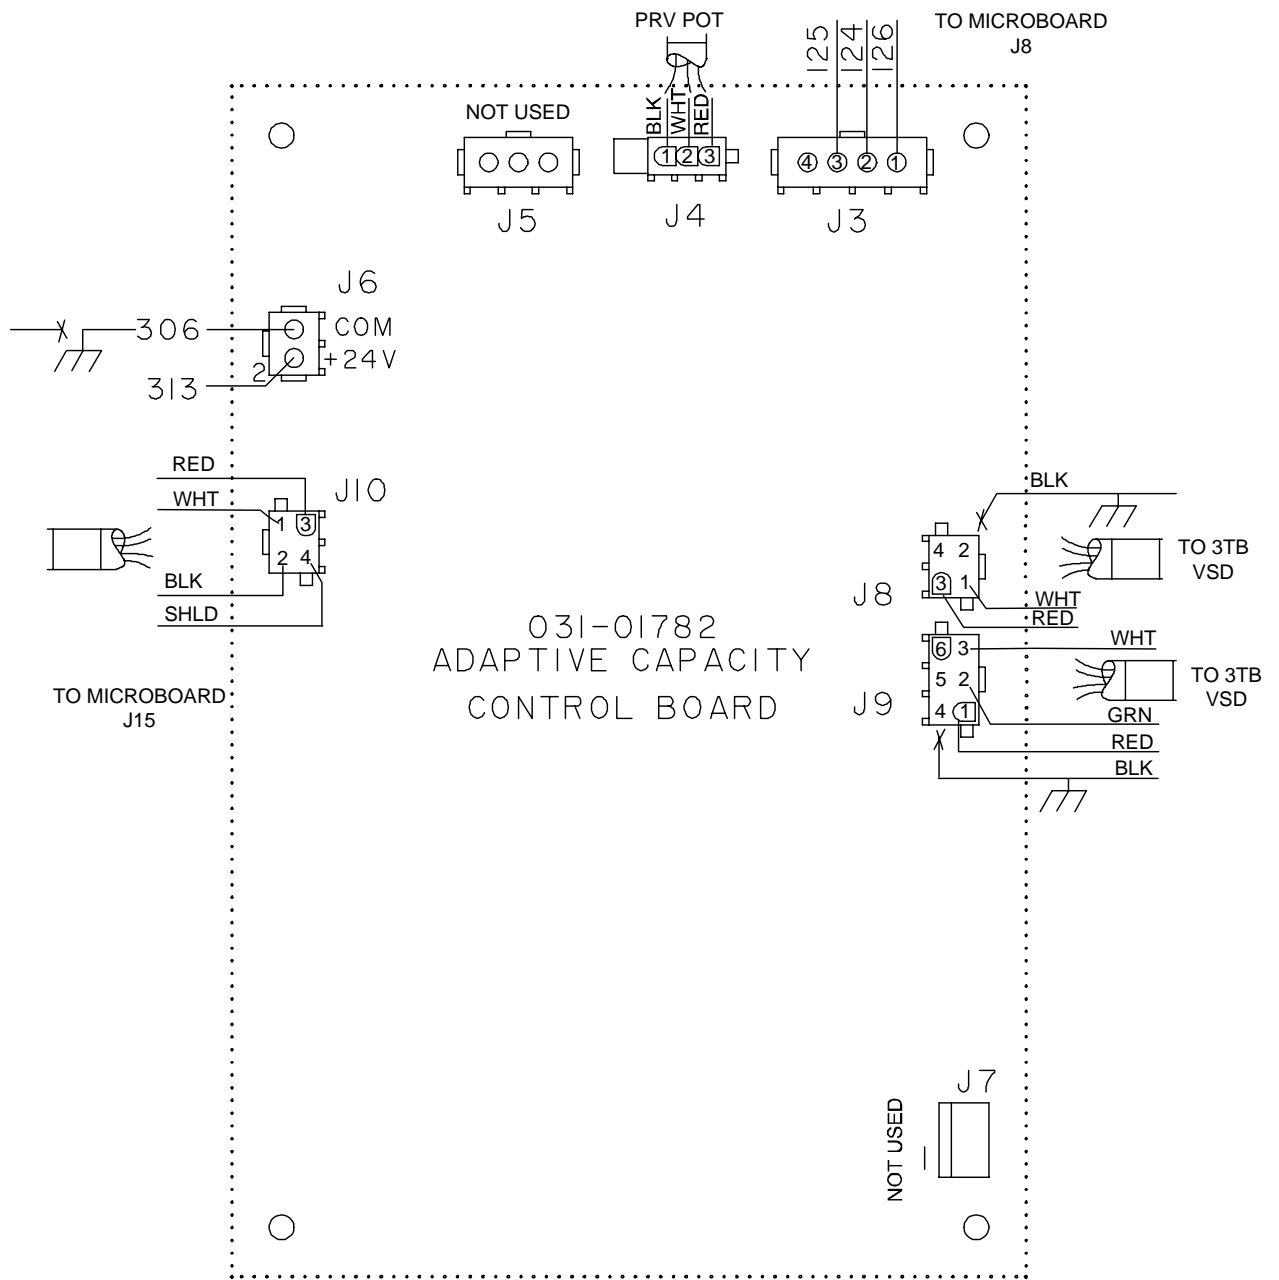
Figure 1 – ACC Board Wiring Changes

Over time the grounding design within the chiller system has changed. These changes do not affect the safety grounding required by UL. However, these changes gradually increase electronic “noise” on the Adaptive Capacity Control board (ACC) to the point the ACC board’s serial communications can lock-up.

For the following procedures refer to Figure 1.

1. At J6 of the ACC board cut wire 306, 2-½ inches from the ACC board. Tape off the wire end that is not connected to the ACC board. Install a lug on the wire end that is still connected to the ACC board. Drill a hole near the ACC board so this lug can be grounded to the OptiView Control Panel's enclosure. Connect the ground to the enclosure with a self-tapping screw.
2. At J8 of the ACC board remove the black wire insert in pin 2 of J8. Cut off the pin and install a lug on the wire so that it can be connected to the OptiView Control Panel's enclosure. Connect this wire to the enclosure where the shield of J8 is connected.
3. If the Harmonic Filter is not installed, then remove the connector installed in J9. This cable should be tied back so that it is not accidentally reinstalled at a later date.

If the Harmonic Filter is installed, then remove the black wire insert in pin 4 of J9 on the ACC board. Cut off the pin and install a lug on the wire so that it can be connected to the OptiView Panel's enclosure. Connect this wire to the enclosure where the shield of J9 is connected

Ensure that ALL metal shavings are removed from the inside of the OptiView Control Panel before reapplying power to the chiller. Damage to electronic boards can result from metal shavings causing shorts.
