Form Number: 160.46-OM3.1 (LS15)	1104
	Supersedes: 160.46-OM3.1 (SB9 & SB11)	
LITERATURE SUPPLEMENT	File with: 160.46-OM3.1 (1191)	
Subject: Liquid Cooled Starter Nuisance 1/2 Phase trips

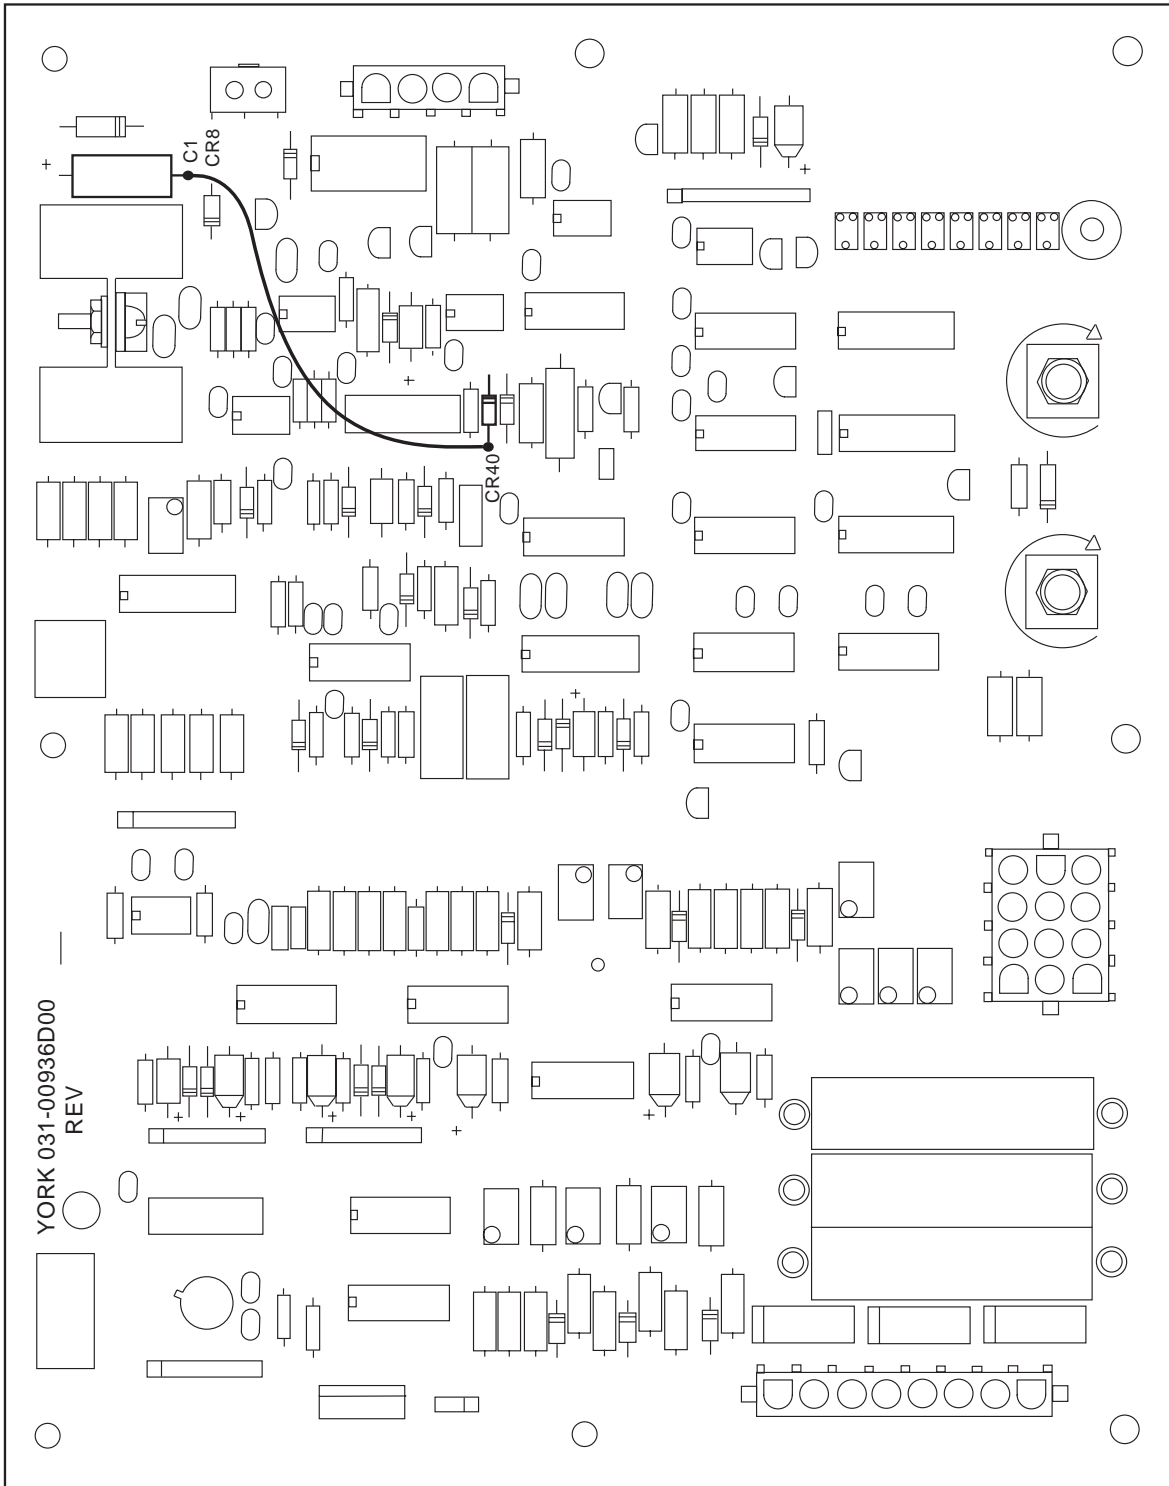
FIG. 1 - SOLID STATE STARTER (STYLE A) LOGICBOARD

The style 'A' solid-state starter logic board has been revised many times over the years to add new features. In 1991 the board was revised to a 'D' level and the 1/2 phase detection circuitry was added. The circuit works well at detection 1/2 phase, but a few site specific conditions can cause the circuit to falsely detect a 1/2 phase.

When troubleshooting a half-phase trip, it is first necessary to determine if the situation is a real event caused by a starter malfunction, or a false trip caused by electrical abnormalities. We have been seeing an increasing number of false trips lately, so we suggest you rule-out the typical false trip conditions first. The three known causes of false trips are:

- 1) High Line Voltage, greater than 500VAC on a 460VAC nominal system, for example. More than 10% above nominal.
- 2) Large Variable Speed Drives on same power distribution, or many smaller drives in combination. Most VSD's create voltage distortion, which distorts our chillers motor's waveform.
- 3) Significant Current Imbalance, greater than 15% from highest leg to the lowest leg. Look at the Control Panel's display just prior to tripping. Note: the highest and lowest values, subtract to get the difference, and divide this number by the value of the lowest leg. If the answer is .15 or more, current imbalance is likely the cause. A 1.5% voltage imbalance will create a 15% or greater current imbalance. The exact amount of current imbalance varies with motor load (%FLA), and increases as the motor unloads.

If tripping is caused by one of these conditions, it would be best to correct the problem at the source, i.e. change transformer taps to lower voltage, put filters on VSD's, or balance out single phase loads to bring voltage balance to within 1%. If this is not possible, you may have no choice but to eliminate the 1/2 phase circuit. **On older rev. 'D' through rev. 'F' boards, you will need to solder a wire jumper as shown on Fig. 1. On (Rev G) and newer starter logic boards, there is a jumper wire, JP1, located approximately 1.5 inch below the large black heatsink in the upper right corner. Cut this jumper to disable the 1/2 phase circuit.**

If none of the three above conditions exist, you likely have a real problem in the LCSSS, and should troubleshoot the starter. The 1/2 phase indicator is intended to signify that one of the six SCR's is not firing. Most common problem areas are the trigger board, connections from the 3-wye to the trigger, and connections from the trigger to the SCR's.
