SERVICE BULLETIN**Affected Equipment:** YCAV & YCIV AIR COOLED CHILLERS**Subject:** Discharge Temperature Sensor Leaks**Issue Date:** 1/24/12**Withdrawal Date:** 1/2/14**Data Control Level:** x**Materials Needed:** 025-32924-000 Discharge Temperature Sensor, one per circuit.**Tools Required:** As needed to replace a defective sensor. This includes general tools of the trade, vacuum pump and a refrigerant cylinder for storing R-134a.**Estimated Time Required:** 4 hours per sensor replacement.**Warranty:** See details within the bulletin.**PROBLEM**

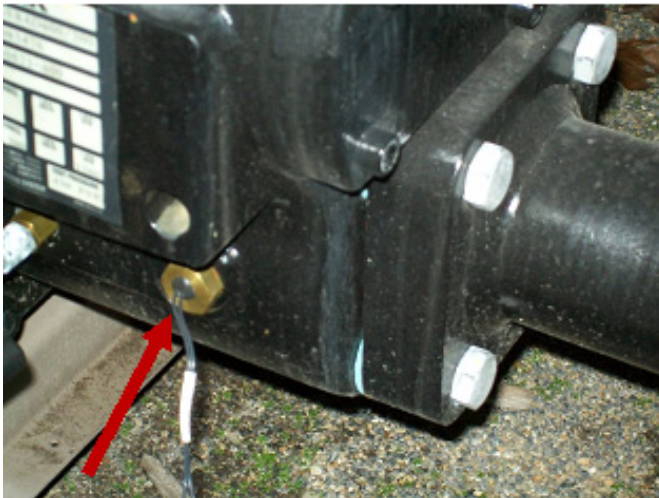
Long body discharge temperature sensors (025-43945-000) threaded into the discharge housing of MTS compressors may fail due to a machining problem that causes the brass sensor body to crack after ongoing exposure to the discharge gas stream in the compressor. When a crack occurs, the sensor will leak refrigerant into the crack in the brass tube exposed to the gas stream and out through the external sensor wiring. The location of the sensor and an example of the long body sensor is shown in *Figures 1* and *2* below.

**FIGURE 1 - DISCHARGE TEMP SENSOR COMPRESSOR LOCATION**

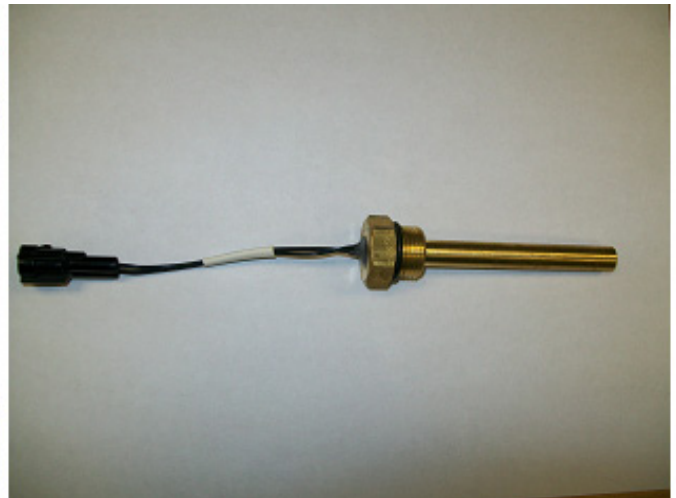
LD16359

FIGURE 2 - LONG BODY SENSOR (025-43945-000 3" SENSOR TUBE)

When a long body sensor on a system fails, the long body sensors on all compressors in the chiller should be changed to the short 1-3/4" body sensor (P/N 025-32924-000), since there is a possibility that all sensors came from the same production lot of sensors and a similar failure may occur on another sensor at a later time. If any short bodied 025-32924-000 sensors are already installed, they do not need to be changed. If multiple YCAV/YCIV chillers were ordered on the same sales order, it will be necessary to change the long body sensors on all chillers. An example of the short body replacement sensor is shown in *Figure 3* below.

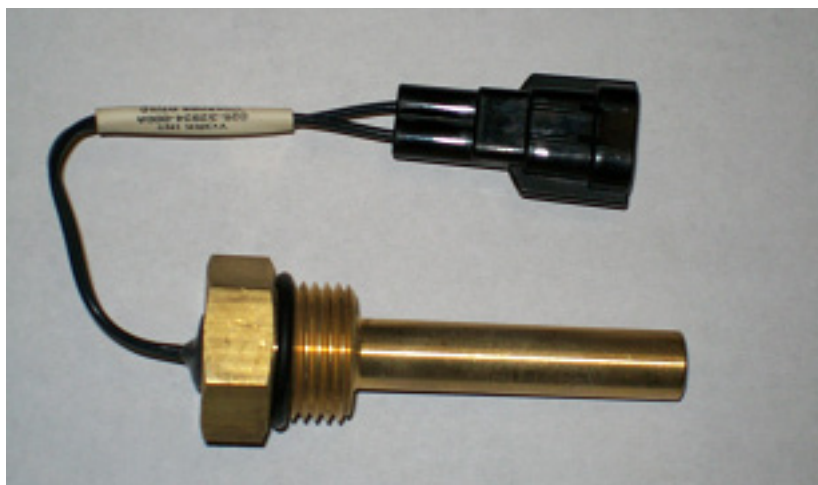
LD16360

FIGURE 3 - SHORT BODY SENSOR P/N 025-32924-000 (1-3/4" SENSOR TUBE)
