Form No: 160.00-M4 (LS01)	1002
	Supersedes: 160.00-M4 (LS01) (702)	
LITERATURE SUPPLEMENT	File with: 160.00-M4	
Subject: Variable Speed Compressor Serial Communications Faults

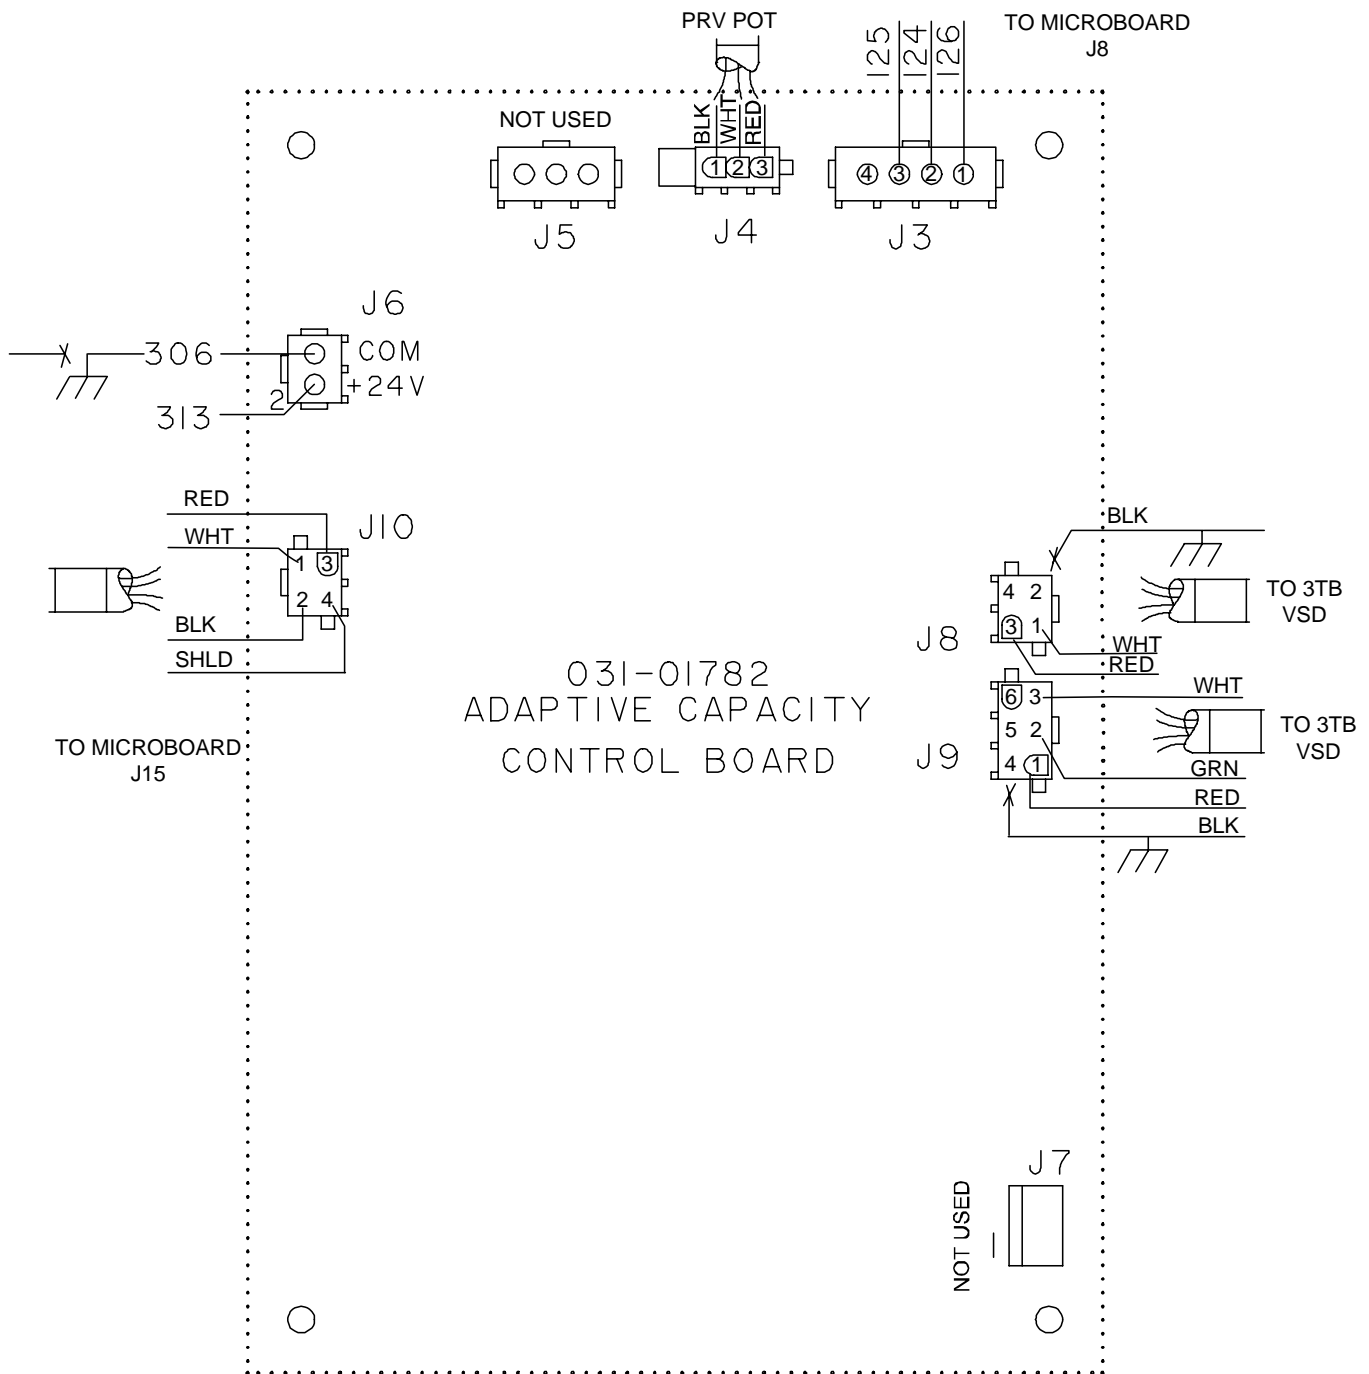
Figure 1 – ACC Board Wiring Changes

Over time the grounding design within the chiller system has changed. These changes do not affect the safety grounding required by UL. However, these changes gradually increase electronic “noise” on the Adaptive Capacity Control board (ACC) to the point the ACC board’s serial communications can lock-up.

For the following procedures refer to Figure 1.

1. At J6 of the ACC board cut wire 306, 2-½ inches from the ACC board. Tape off the wire end that is not connected to the ACC board. Install a lug on the wire end that is still connected to the ACC board. Drill a hole near the ACC board so this lug can be grounded to the OptiView Control Panel's enclosure. Connect the ground to the enclosure with a self-tapping screw.
2. At J8 of the ACC board remove the black wire insert in pin 2 of J8. Cut off the pin and install a lug on the wire so that it can be connected to the OptiView Control Panel's enclosure. Connect this wire to the enclosure where the shield of J8 is connected.
3. If the Harmonic Filter is not installed, then remove the connector installed in J9. This cable should be tied back so that it is not accidentally reinstalled at a later date.

If the Harmonic Filter is installed, then remove the black wire insert in pin 4 of J9 on the ACC board. Cut off the pin and install a lug on the wire so that it can be connected to the OptiView Panel's enclosure. Connect this wire to the enclosure where the shield of J9 is connected
