ES Service Information

SI0120

Equipment Affected: Chillers with 292/351 & 419/503 VSD Drives

Trap Filter Resistor Wire Routing

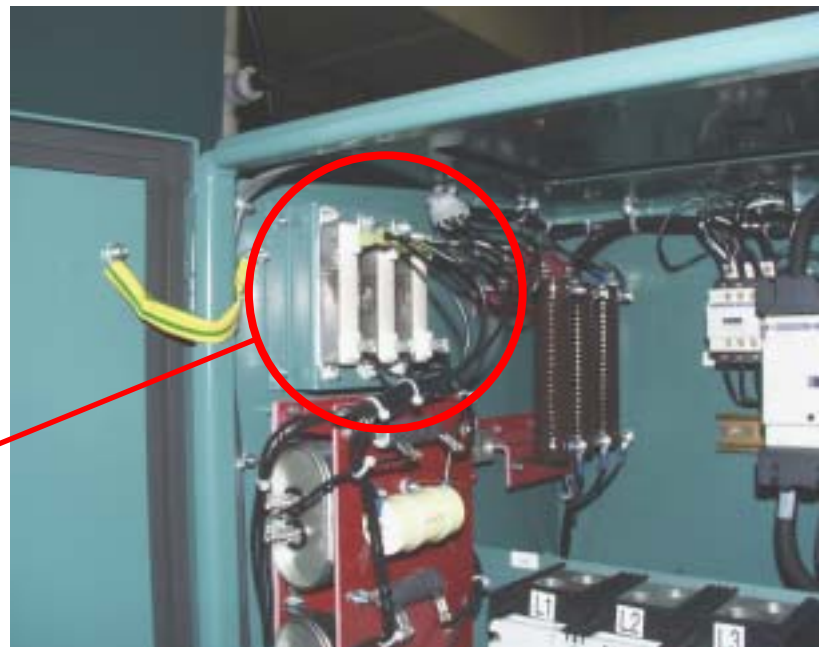
Fig. 1 shows the general location of the trap filter power resistors.

FIG.1 - LOCATION OF TRAP FILTER POWER RESISTORS

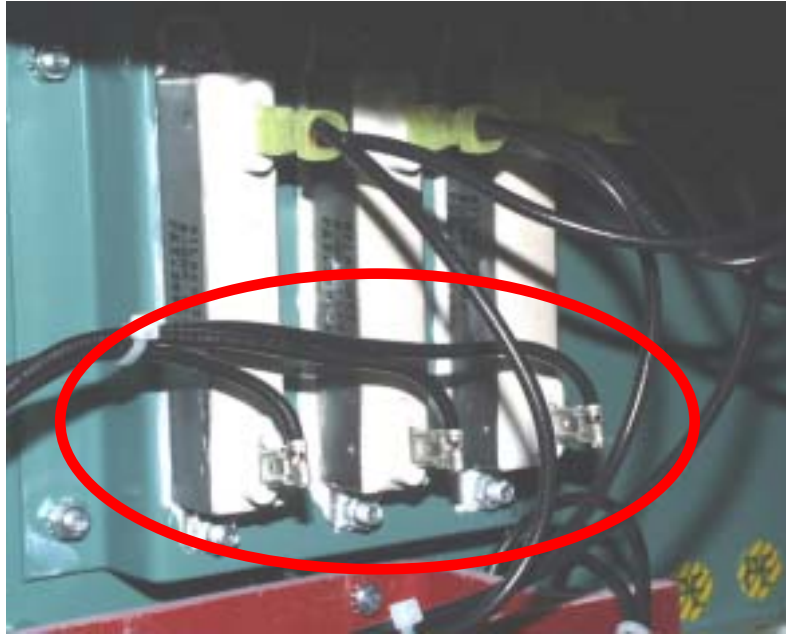
In Fig. 2, notice that the wiring for the trap resistors loops back up over the resistor. Over time and with heating in the drive, the wire may eventually "droop" and make contact with the metal resistor body. This will cause the wire insulation to fail and the input phase will short to ground.

FIG. 2 - WIRE ROUTING IS INCORRECT ON THE BOTTOM OF THE TRAP FILTER POWER RESISTORS

To reroute the wiring, remove power from the unit and gently remove the lead from the bottom of each trap filter power resistor. Rotate the wiring connector 180° and reinstall the wiring connector. Route the wiring down away from the trap power resistors, and tie wrap these wires to the wiring at the top of the red plate. In Fig. 3 notice how the trap power resistor wiring is now routed away from the metal body of the resistor, and is not able to short the wire to ground.

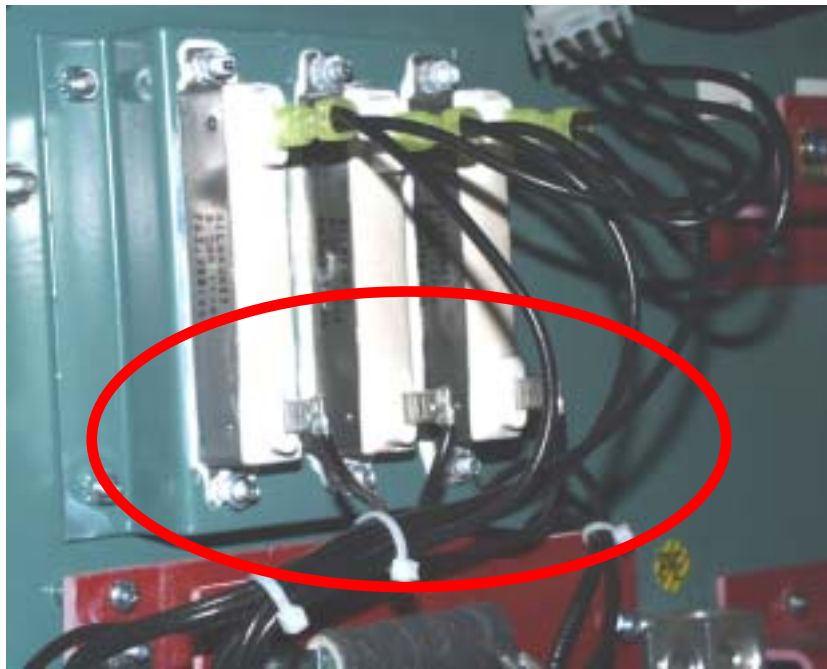
FIG. 3 - WIRE ROUTING IS CORRECT ON THE BOTTOM OF THE TRAP FILTER POWER RESISTORS
