ESG Service Information

SI0041

Equipment Affected: YK Chillers

Proximity Probe Troubleshooting

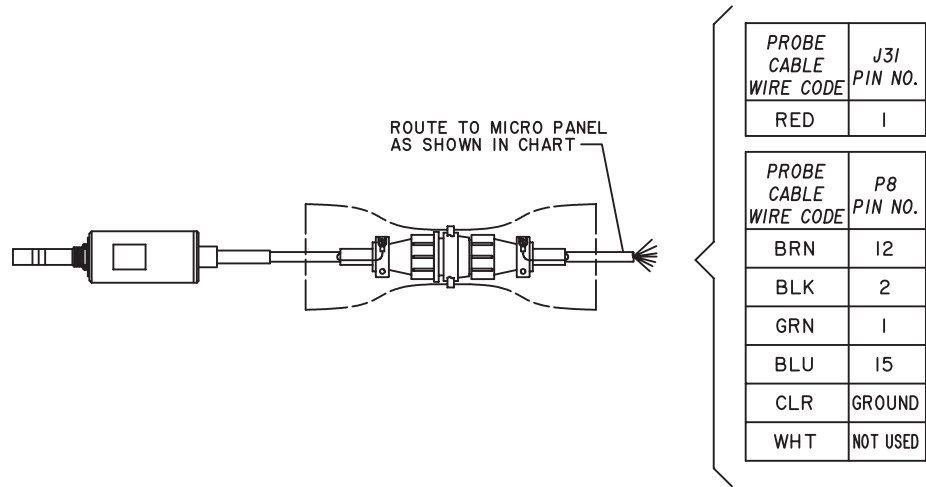
FIGURE 1 - GRAPHIC STYLE PANEL

Electrical Pin & Socket Part Numbers:
 Female Sockets (4 Required) 025-28386-000
 Male Pin (1 Required) 025-18443-000

When the proximity probe is replaced, it is recommended the cable that comes with the new probe be installed. When replacing the probe and cable you will need to order new wiring pins and sockets for the connection of the cable to the micro panel. The part numbers of these pins and sockets along with connection drawings for the different style micro panels are shown in Figures 1 & 2. A new "O"-ring (p/n 028-12209-000) will be needed for installing the new probe.

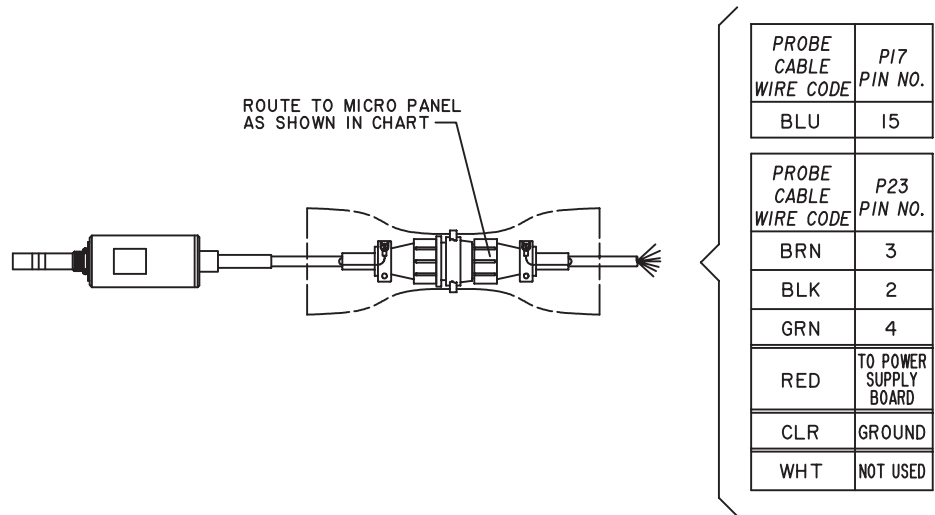
FIGURE 2 - SINGLE LINE DISPLAY PANEL

Electrical Pin & Socket Part Numbers:
 Female Sockets (4 Required) 025-28386-000
 Male Pin (1 Required) 025-19674-000

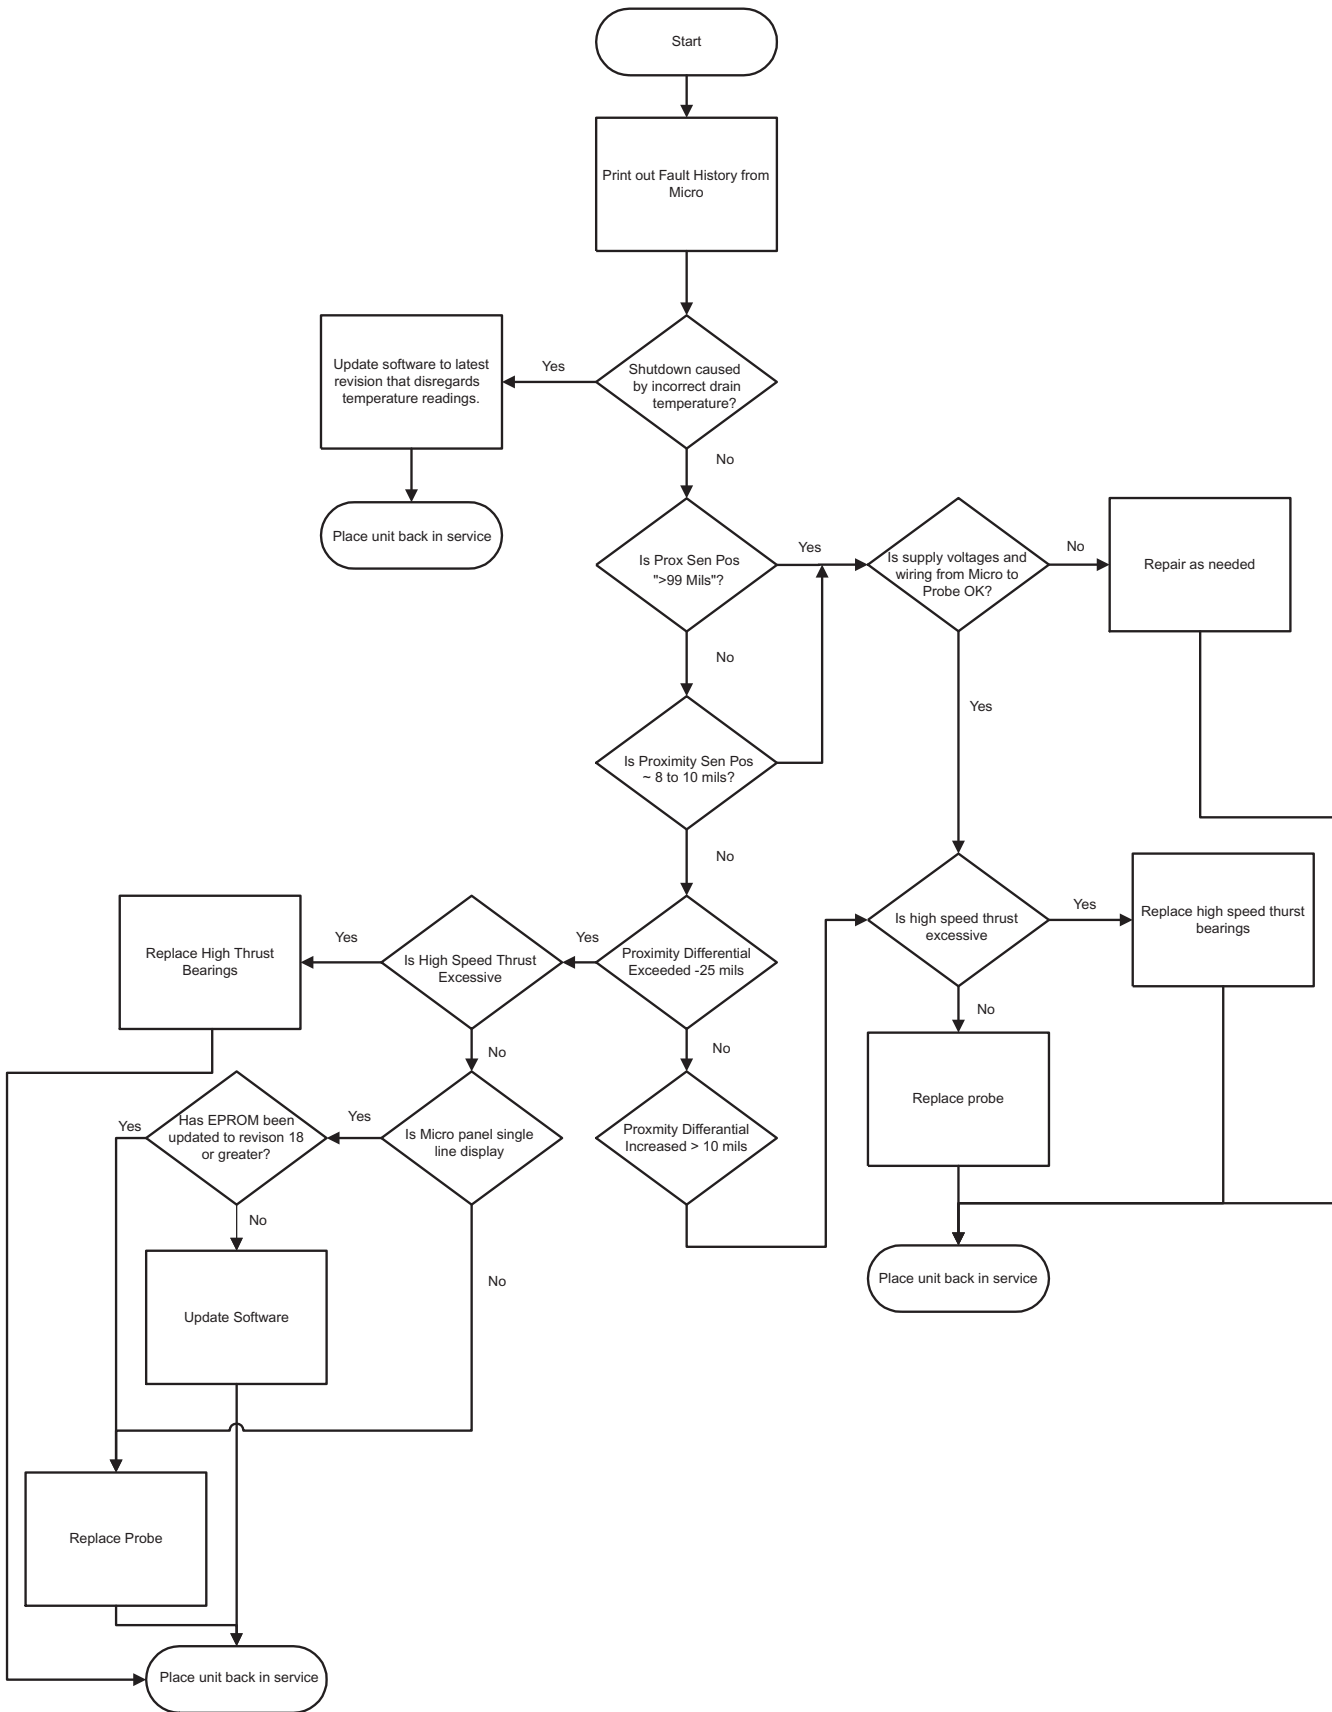
FIGURE 3 - PROXIMITY PROBE TROUBLESHOOTING

The information in this letter will help the technician recognize and trouble shoot chiller shutdowns caused by promixity probe faults. The trouble shooting process is described below and as a flow chart in Figure 3.

There are 3 common types of proximity probes failure that trigger unnecessary shutdowns on thrust collar position. These faults are listed below.

The voltage signal from the probe to the micro panel will be around 5 volts. This results in “>99 mils” display for the thrust collar position in the history print.

The voltage signal returning to the micro panel will be very low (around 0 volts). The printout will display a thrust collar position very low, somewhere around **8 to 10 mils**.

This causes chiller shut down even though there is not an actual change of thrust collar position. A quick way of checking for excessive thrust is to check the high speed axial thrust by using the proximity probe reading from the micro panel.

- In both of the above faults, be sure that all electrical connections between the micro panel and the probe are secure and the fault is not being caused by an intermittent wiring connection problem. Also check that the 24 and 5 volt supplies to the probe are good at both the micro panel and at the military connector where the probe connects to the cable from the micro panel.

1. Rotate the compressor low speed shaft by hand a few revolutions in the direction of normal rotation.
2. Record the reading from the micro panel for thrust collar position.
3. After documenting the first reading, slowly rotate the compressor shaft in the opposite rotation a few revolutions and record the thrust collar position reading from the micro panel.
4. The difference in the 2 readings is a rough estimation of the high-speed axial thrust.

Rotating the compressor back and forth will drive the high-speed assembly in the forward and reverse thrust directions by using the pitch of the gear teeth. If after rotating the compressor the results are inconclusive, the only sure way of checking for thrust wear is to remove the refrigerant charge and inspect the thrust bearings. After checking the high speed thrust bearings and finding they are OK, then the problem is most likely the proximity probe and it should be replaced.
