Form No.: 160.00-M1 (LS01)	801
	Supersedes: None	
LITERATURE SUPPLEMENT	File with: 160.00-M1	
Subject: IEEE 519 Logic Board Software Upgrade

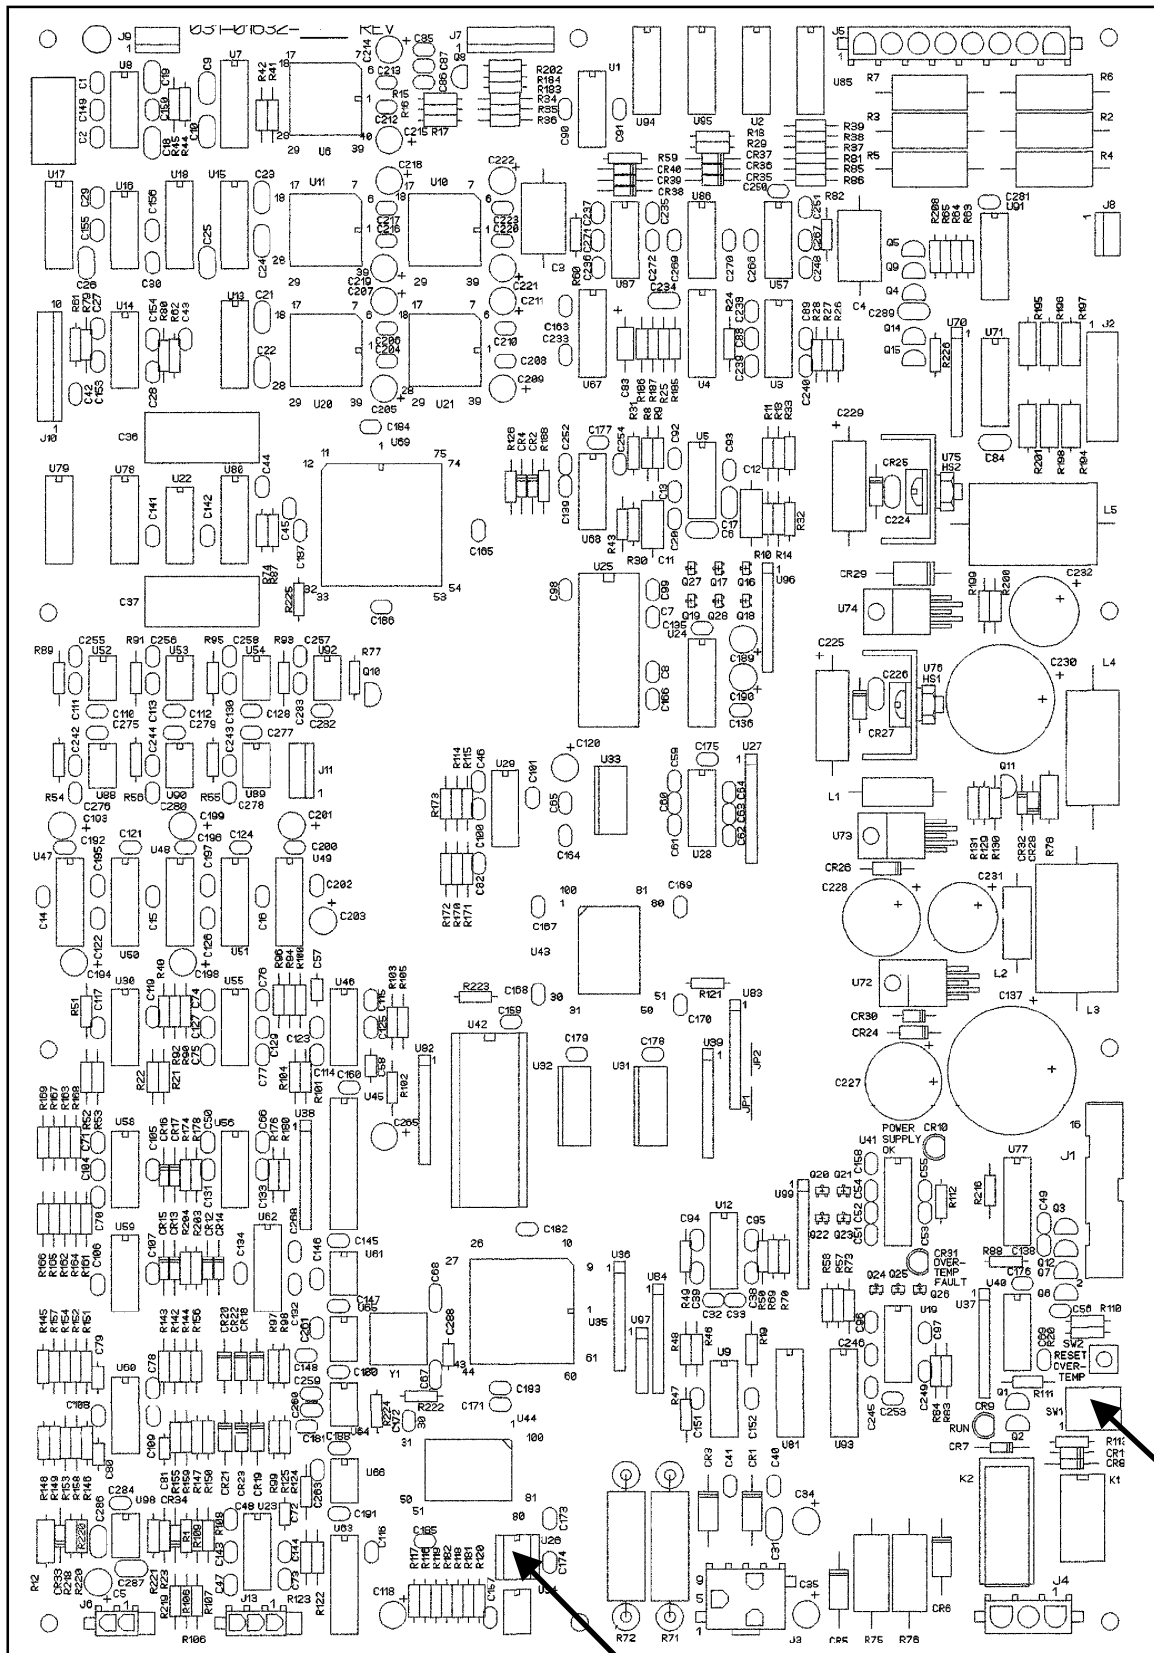
Recent field reports have indicated that chiller shutdowns are sometimes occurring due to the 519 filter having filter phase over current faults. Most of these faults have been caused by the switching of power factor capacitors by the utility, or locally by the customer. These same faults can occur when the customer has a heavily loaded transformer. This software upgrade will eliminate most of the nuisance filter phase over current faults.

U26
Note that "notch" is up

SW1

Refer to the back of this sheet for the location of U26 on the logic board. Remove the existing chip in the U26 slot from the 519 filter logic board (031-01632-0XX) and replace it with the new chip from the Baltimore Parts Center check sum EA3B. When installing the new chip ensure that the notch on the chip is pointed toward the top of the board.

If the filter has been disabled, then reconnect the 16 pin ribbon cable between the VSD logic board and the 519 filter logic board. Place SW1 in the up position. Refer to the back of this sheet for the location of SW1.
