Form No.: 160.00-M1 (LS01)	801
	Supersedes: None	
<b>LITERATURE SUPPLEMENT</b>	File with: 160.00-M1	
Subject: IEEE 519 Logic Board Software Upgrade

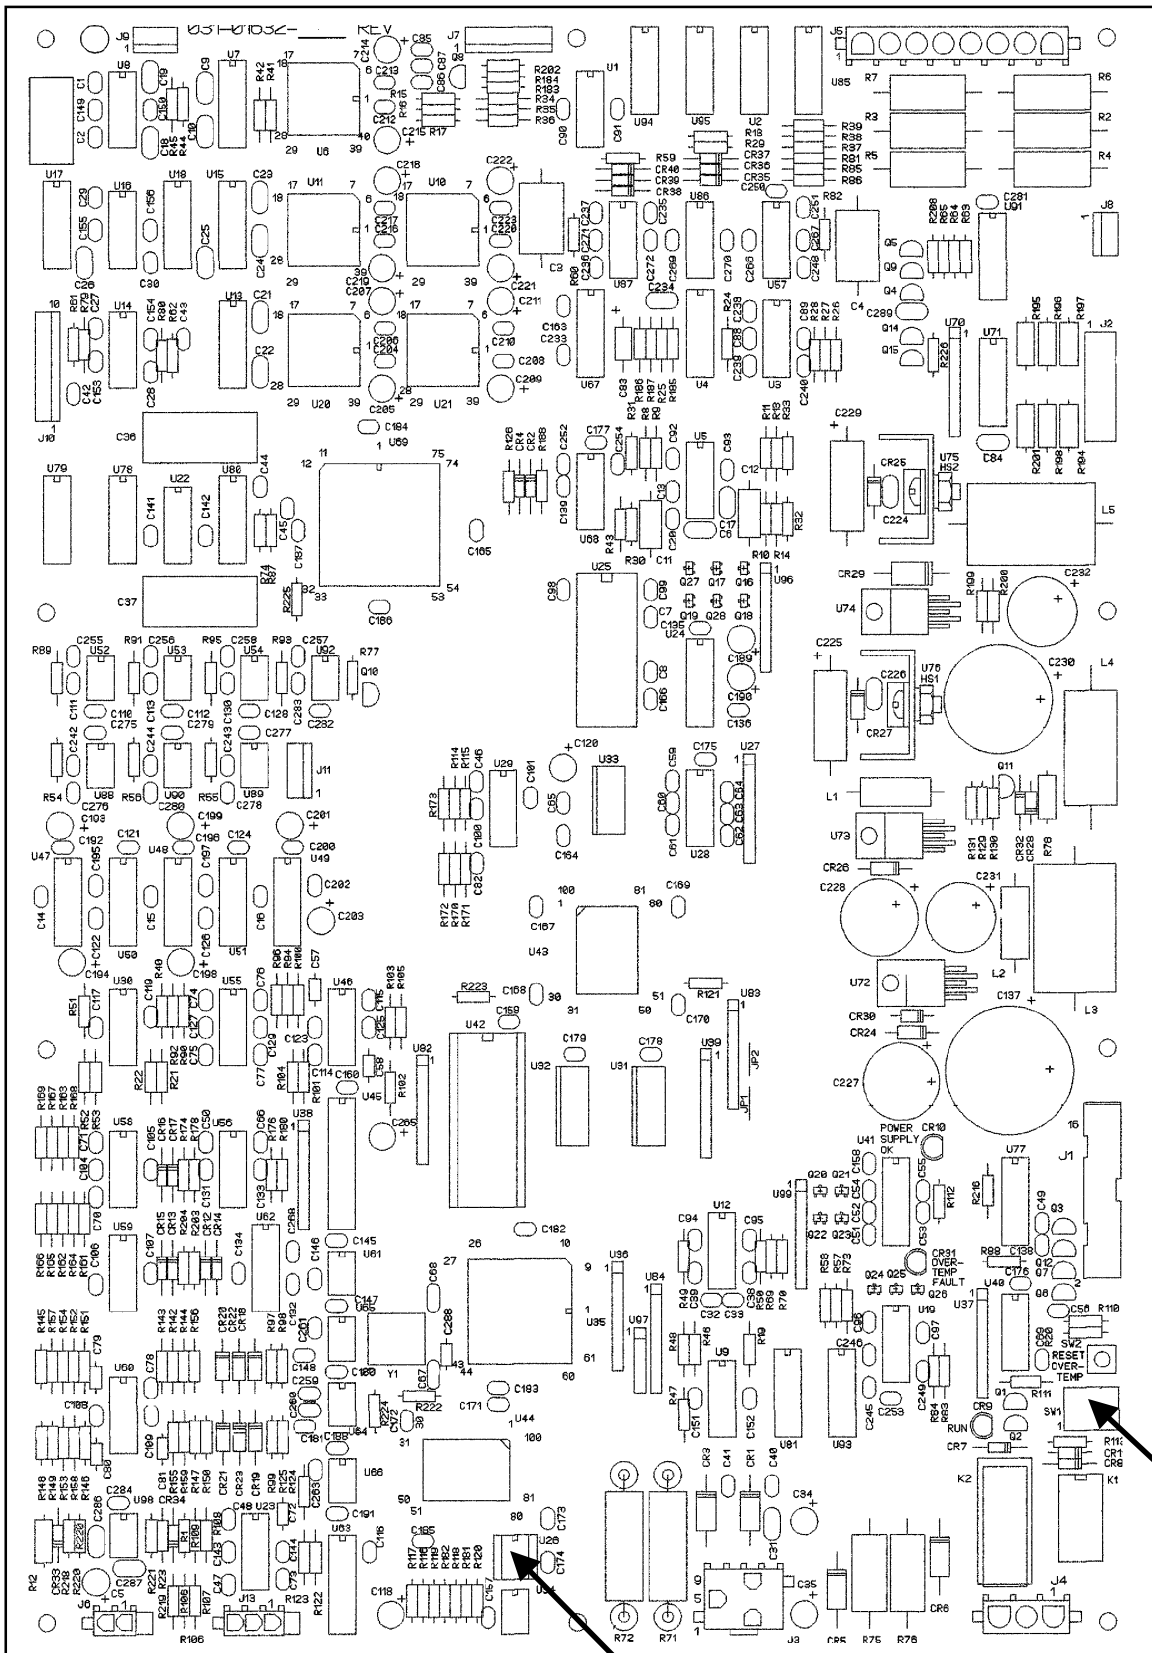
TOP of BOARD

Recent field reports have indicated that chiller shutdowns are sometimes occurring due to the 519 filter having filter phase over current faults. Most of these faults have been caused by the switching of power factor capacitors by the utility, or locally by the customer. These same faults can occur when the customer has a heavily loaded transformer. This software upgrade will eliminate most of the nuisance filter phase over current faults.

U26  
Note that "notch" is up

SW1

If you are experiencing this type of problem with a 519 filter, then order the upgraded U26 chip from the Baltimore Parts Center. The part number for the chip is 031-01680-002 and the check sum is EA3B.

Refer to the back of this sheet for the location of U26 on the logic board. Remove the existing chip in the U26 slot from the 519 filter logic board (031-01632-0XX) and replace it with the new chip from the Baltimore Parts Center check sum EA3B. When installing the new chip ensure that the notch on the chip is pointed toward the top of the board.

If the filter has been disabled, then reconnect the 16 pin ribbon cable between the VSD logic board and the 519 filter logic board. Place SW1 in the up position. Refer to the back of this sheet for the location of SW1.
