BY JOHNSON CONTROLS

Service Information

SI0228

PROCEDURES TO FOLLOW BEFORE CHANGING A SUSPECTED LEAKING COIL

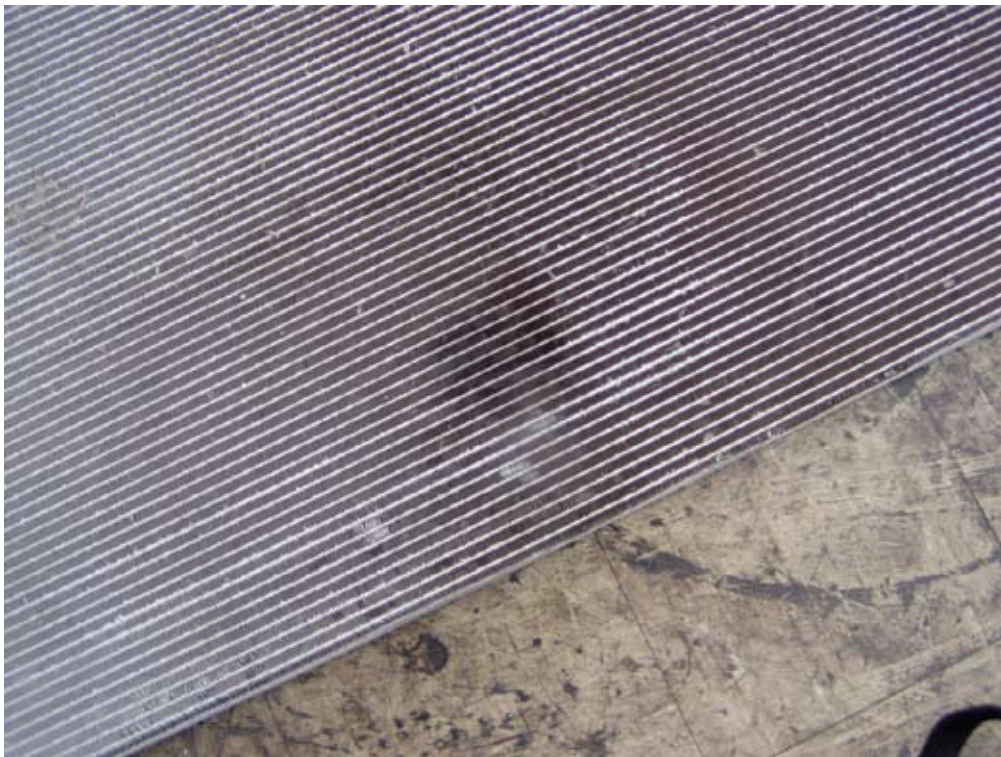
LD14680

Stain on coil incorrectly assumed to be a leak.

The stain on the coil in the photo above was not caused by a leak. This instruction is intended to alert technicians of this situation and outline recommended leak check procedures to verify a leaking coil.

Always check the suspect coil for an actual leak using an electronic leak detector or soap bubbles. If a leak cannot be detected in the coil, it probably doesn't exist. If a leak is detected, mark the location on the coil with spray paint. When possible, spray paint a small circle around the area to identify the location or paint an arrow pointing to the leak area. This will aid in identifying the leak location when the coil is returned to the Warranty Return Center. Also, keep in mind that if a leak is caused by obvious contact damage to the coil, it should not be repaired on a warranty. Leaking coils damaged by impact will be back charged as well as coils that are replaced under warranty and not returned to the Warranty Return Center. If a coil is changed in error, contact the Warranty Return Center and let them know that a mistake was made so it can be accounted for correctly in the warranty system.

If there is no doubt that the stain is the result of oil, check other surrounding areas for leaks such as relief valves, fittings, etc., that could have caused oil to be sprayed or pulled into the coil due to air flow from the fans. Keep in mind that in most cases, the stain or discoloration is due to one or more of the following:
