ES SERVICE BULLETIN**Affected Equipment: YPAL MOD "D"
Packaged Rooftop Units w/Heat****Subject: Overheating Conditioned Space****Issue Date: 12/01/06****Withdrawal Date: 06/30/07****Data Control Level: C****Materials Needed: N/A****Tools Required: Standard Hand Tools****Est. Time Required: 1 Hour plus Travel Time****Warranty: Yes****Revision Notes: N/A****Issue:**

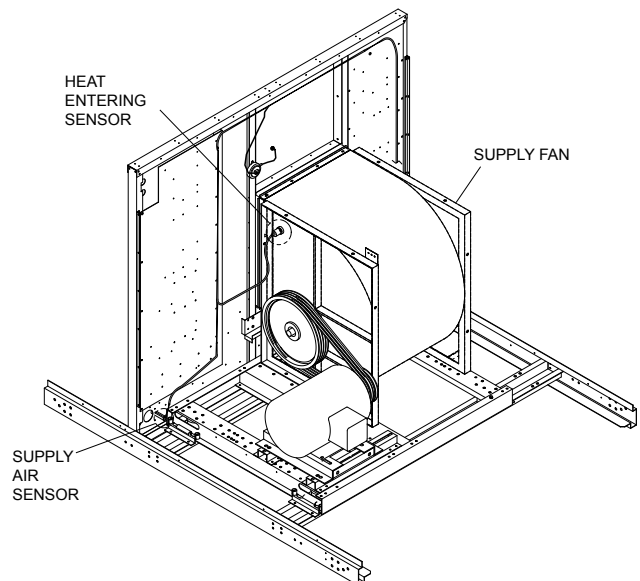
Sensor wiring was incorrectly installed at the factory. The wires that are supposed to be wired to the supply air sensor were connected to the heat entering sensor, and the wires that should be connected to the heat entering sensor were connected to the supply air sensor.

Location of these two sensors is shown at right. The heat entering sensor is located in the side scroll of the blower housing. The supply air sensor is installed in the end of the aspirator tube that runs under the heat exchanger. The supply air sensor can be found in the blower compartment in the area where the refrigerant piping goes through the wall between the blower and the supply air compartments.

The sensors are connected to the unit wiring with ¼ inch male connectors.

- Remove wires 308 and 309 from the heat entering sensor.
- Remove wires 310 and 311 from the supply air sensor.
- Connect wires 308 and 309 to the supply air sensor and wires 310 and 311 to the heat entering sensor.
