BY JOHNSON CONTROLS

Service Information

SI0228

PROCEDURES TO FOLLOW BEFORE CHANGING A SUSPECTED LEAKING COIL

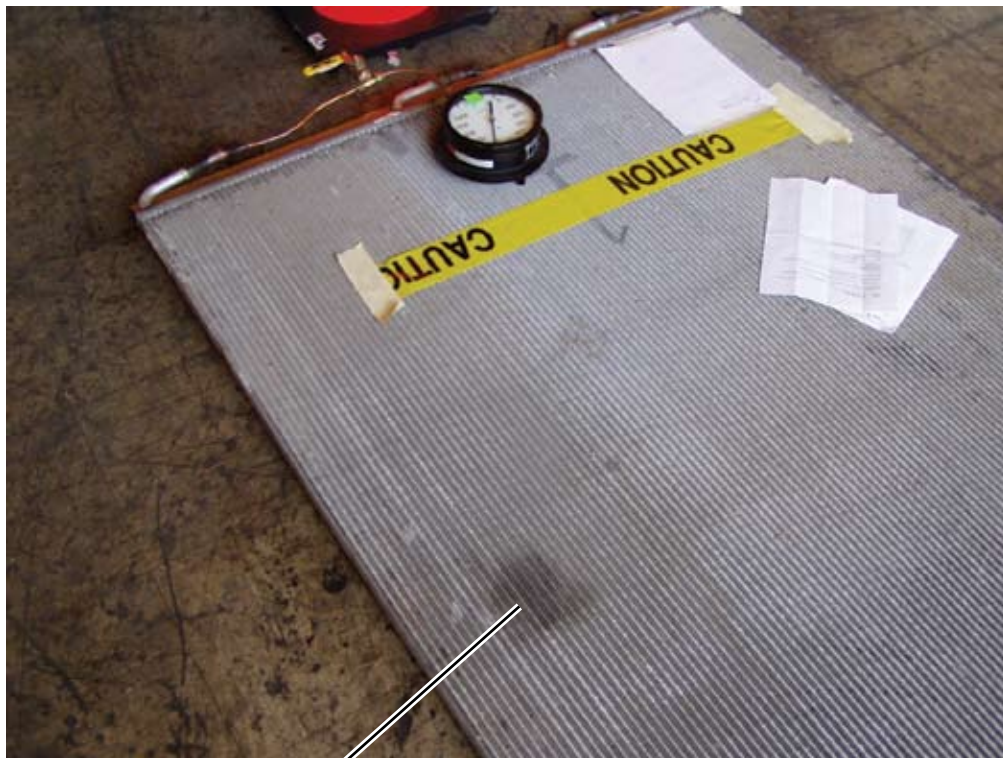
LD14679

Stain on coil incorrectly assumed to be a leak.

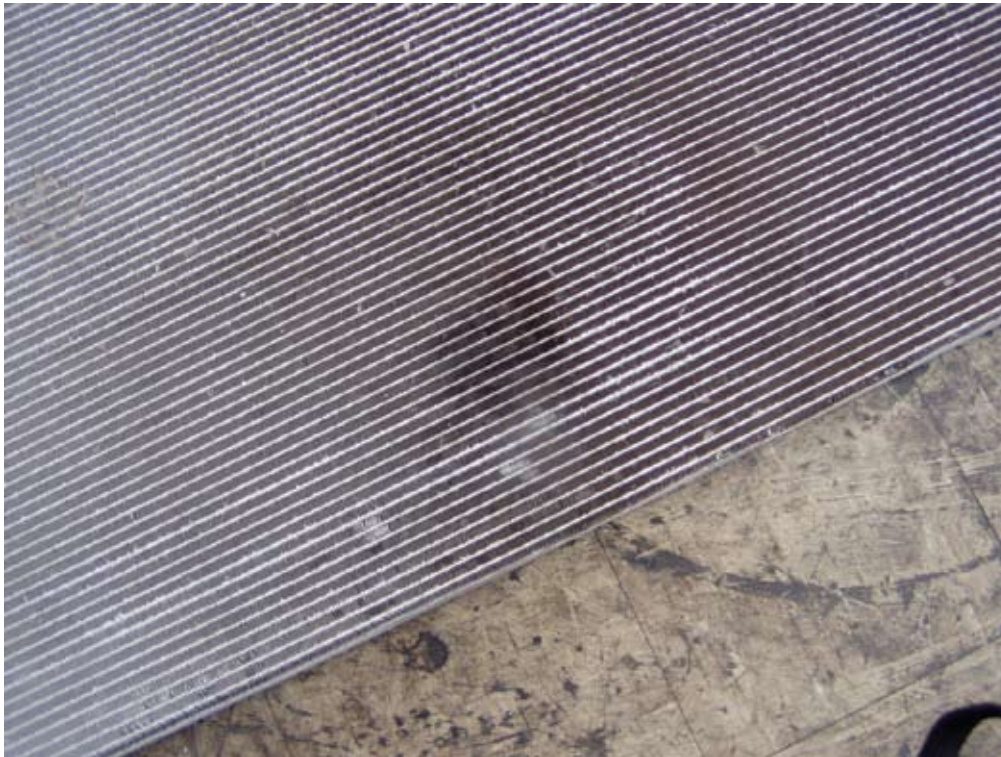
LD14680

The stain on the coil in the photo above was not caused by a leak. This instruction is intended to alert technicians of this situation and outline recommended leak check procedures to verify a leaking coil.

Always check the suspect coil for an actual leak using an electronic leak detector or soap bubbles. If a leak cannot be detected in the coil, it probably doesn't exist. If a leak is detected, mark the location on the coil with spray paint. When possible, spray paint a small circle around the area to identify the location or paint an arrow pointing to the leak area. This will aid in identifying the leak location when the coil is returned to the Warranty Return Center. Also, keep in mind that if a leak is caused by obvious contact damage to the coil, it should not be repaired on a warranty. Leaking coils damaged by impact will be back charged as well as coils that are replaced under warranty and not returned to the Warranty Return Center. If a coil is changed in error, contact the Warranty Return Center and let them know that a mistake was made so it can be accounted for correctly in the warranty system.
