FILE IN _____ SK _____ MANUAL(S).	
	SERVICE BULLETIN	Supersedes: Nothing
		File with Form: 160.65-OM1

SUBJ.: LOSING VAR. SET POINTS
ON THE 1250 TON SCREW

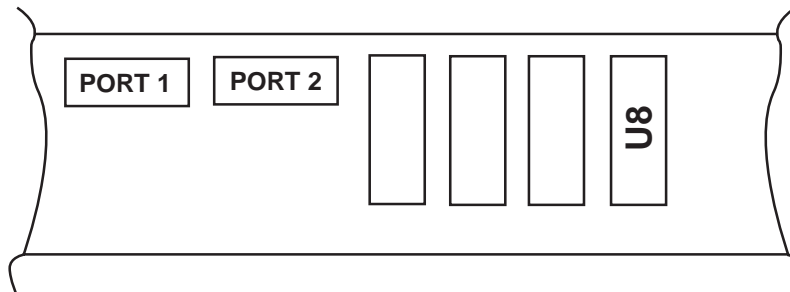
LD04143

PROBLEM: On the 1250 ton screw chiller the panel loses its variable set points for no apparent reason.

SOLUTIONS: The problem is the U8 chip on the micro board. To resolve this problem you must replace the micro board. You will find below a drawing (footprint) of the defective chip. If the footprint is as shown below the chip is your problem.

LOCATION OF U8 CHIP ON THE MICROBOARD
