BY JOHNSON CONTROLS

Service Information

SI0211

Equipment Affected: Multi-Stage Compressors

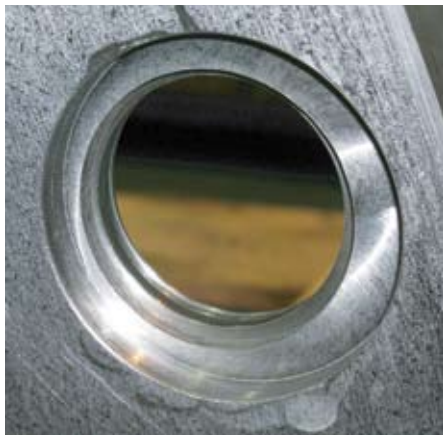
FIG. 2 – DIFFUSER PLATE

The balance piston tube through-hole in the last stage exit plate now has added a counterbore that is eccentric to the through-hole (see FIG. 2). The tubing clamp/balance piston tube assembly is carefully inserted using caution not to damage the seal rings and is flush with the diffuser exit plate surface (see FIG. 4). The seal ring arrangement is unchanged from the existing design. Once installed, the piston ring housing holds the balance piston tube in place (see FIG. 5). Should removal be required, it is simply a matter of sliding the tube clamp assembly out from its counterbore.
