Report of Eddy Current Inspection

Manufacturer: York

Model: OTT4G2-ZBES

Location: DUPONT EXPERIMENTAL STATION
RTE. 141 BETWEEN 52 & 202
WILMINGTON, DE 19735

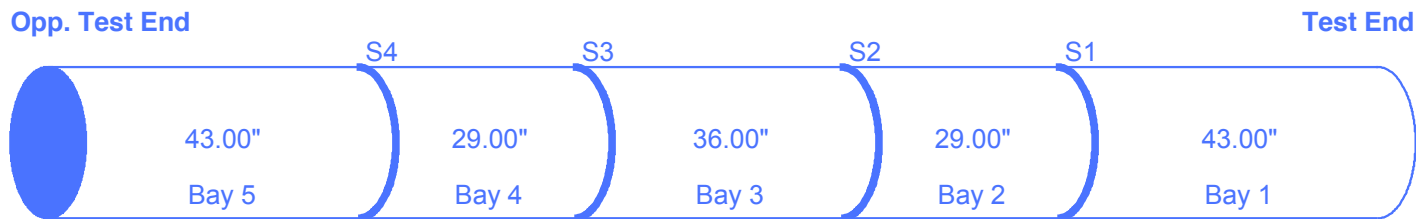
**Condenser (Length = 180 inches)
S = Intermediate Support**

Bay 5	43.00"
Bay 4	29.00"
Bay 3	36.00"
Bay 2	29.00"
Bay 1	43.00"

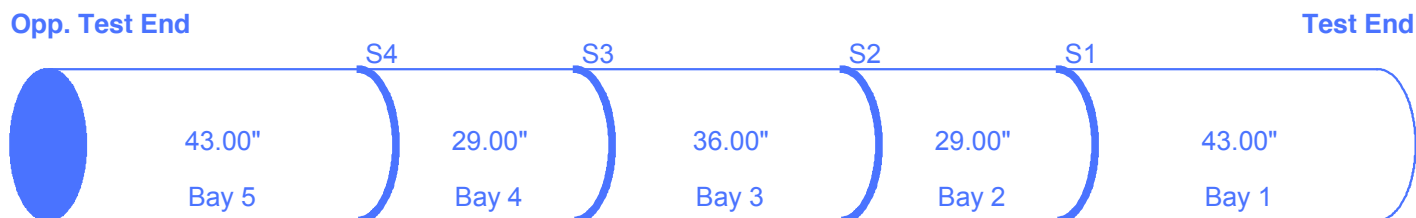
**Evaporator (Length = 180 inches)
S = Intermediate Support**

Bay 5	43.00"
Bay 4	29.00"
Bay 3	36.00"
Bay 2	29.00"
Bay 1	43.00"

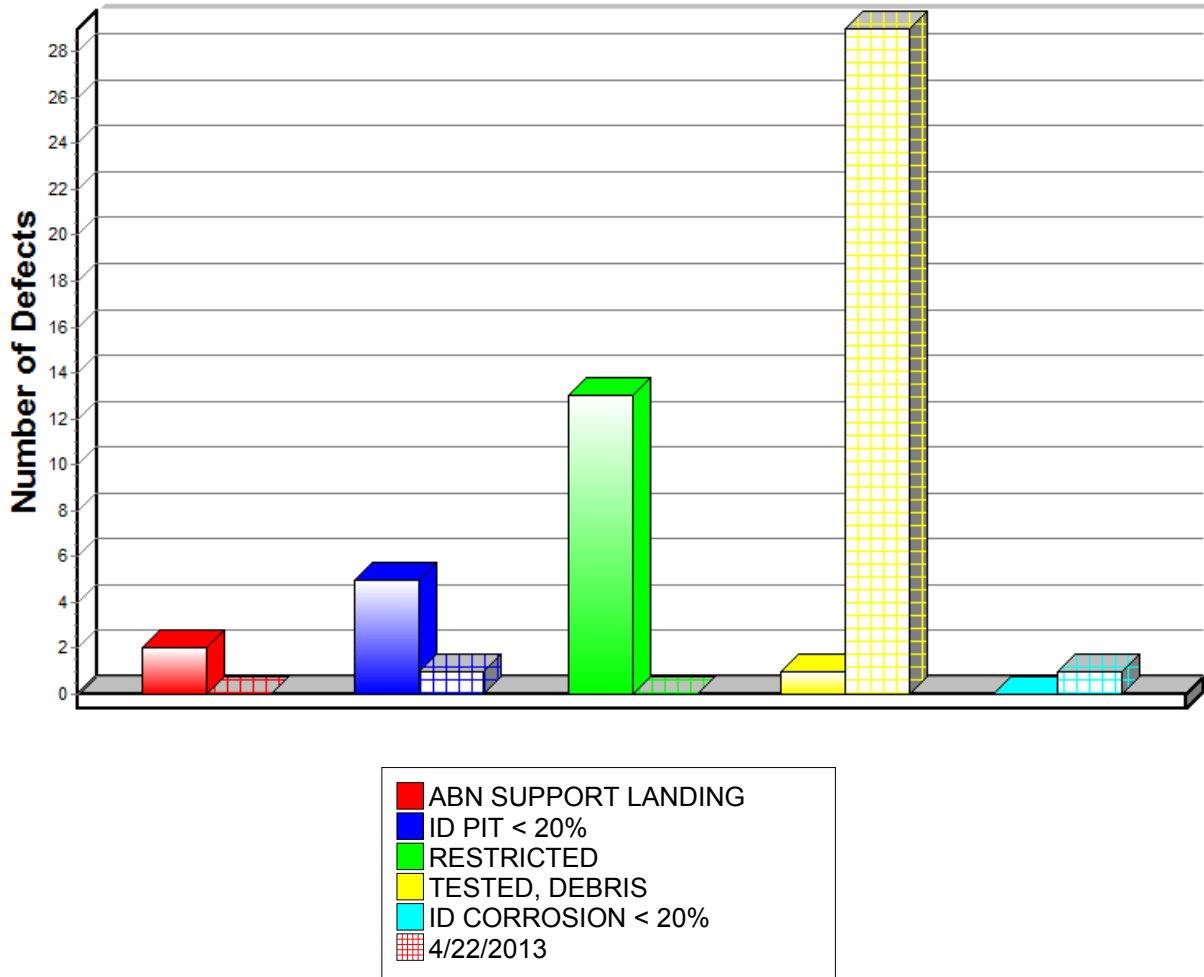
Condenser Defects

Condenser: 883 Tubes		
Tubes Tested: 883 Tubes		
Significant/Measurable Indications	Number of Tubes Marked	Percent of Bundle
ABN SUPPORT LANDING	2	.23
ID PIT < 20%	5	.57
RESTRICTED	13	1.47
TESTED, DEBRIS	1	.11
Totals	21	2.38

NOTE: The tubes in this bundle showed excessive noise believed to be the result of the manufacturing process. Noise is not detrimental to the tubes performance but could mask or distort small tube damage indications.

Tubes indicating Abnormal Support Landings require no corrective action at this time.

The ID Pits marked require no immediate corrective action. However, this type damage is usually progressive and should be monitored.

Tubes marked as Restricted contained defects, or foreign material which prevented the inspection probe from passing. As both heads were removed, the tubes were inspected from Opposite Test End side up to the restricted point from that end. No defects were detected.

The tubes marked as Tested Debris contained foreign material. No damage was detected and no corrective action is required. It should be noted that the tubes in this bundle contained foreign material. This material could possibly mask, or be interpreted as tube damage.

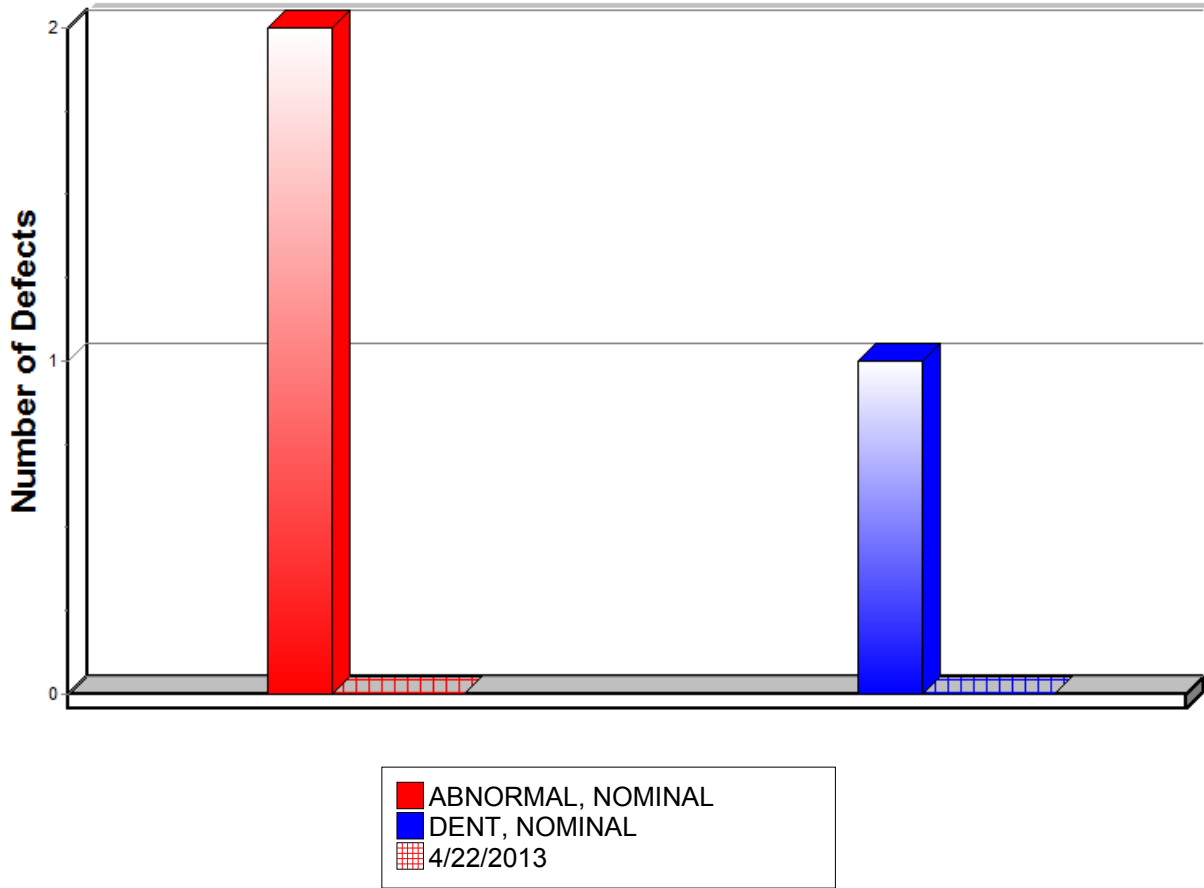
Evaporator Defects

Evaporator: 699 Tubes		
Tubes Tested: 699 Tubes		
Significant/Measurable Indications	Number of Tubes Marked	Percent of Bundle
ABNORMAL, NOMINAL	2	.29
DENT, NOMINAL	1	.14
Totals	3	.43

Tubes indicating Abnormal Nominal Indications require no corrective at this time.

Tubes indicated as "Dent, Nominal" require no corrective action at this time.
