ITP 329

Pump Service & Maintenance  
2017

Troubleshooting with Pump Curves and  
Pressure Gauges

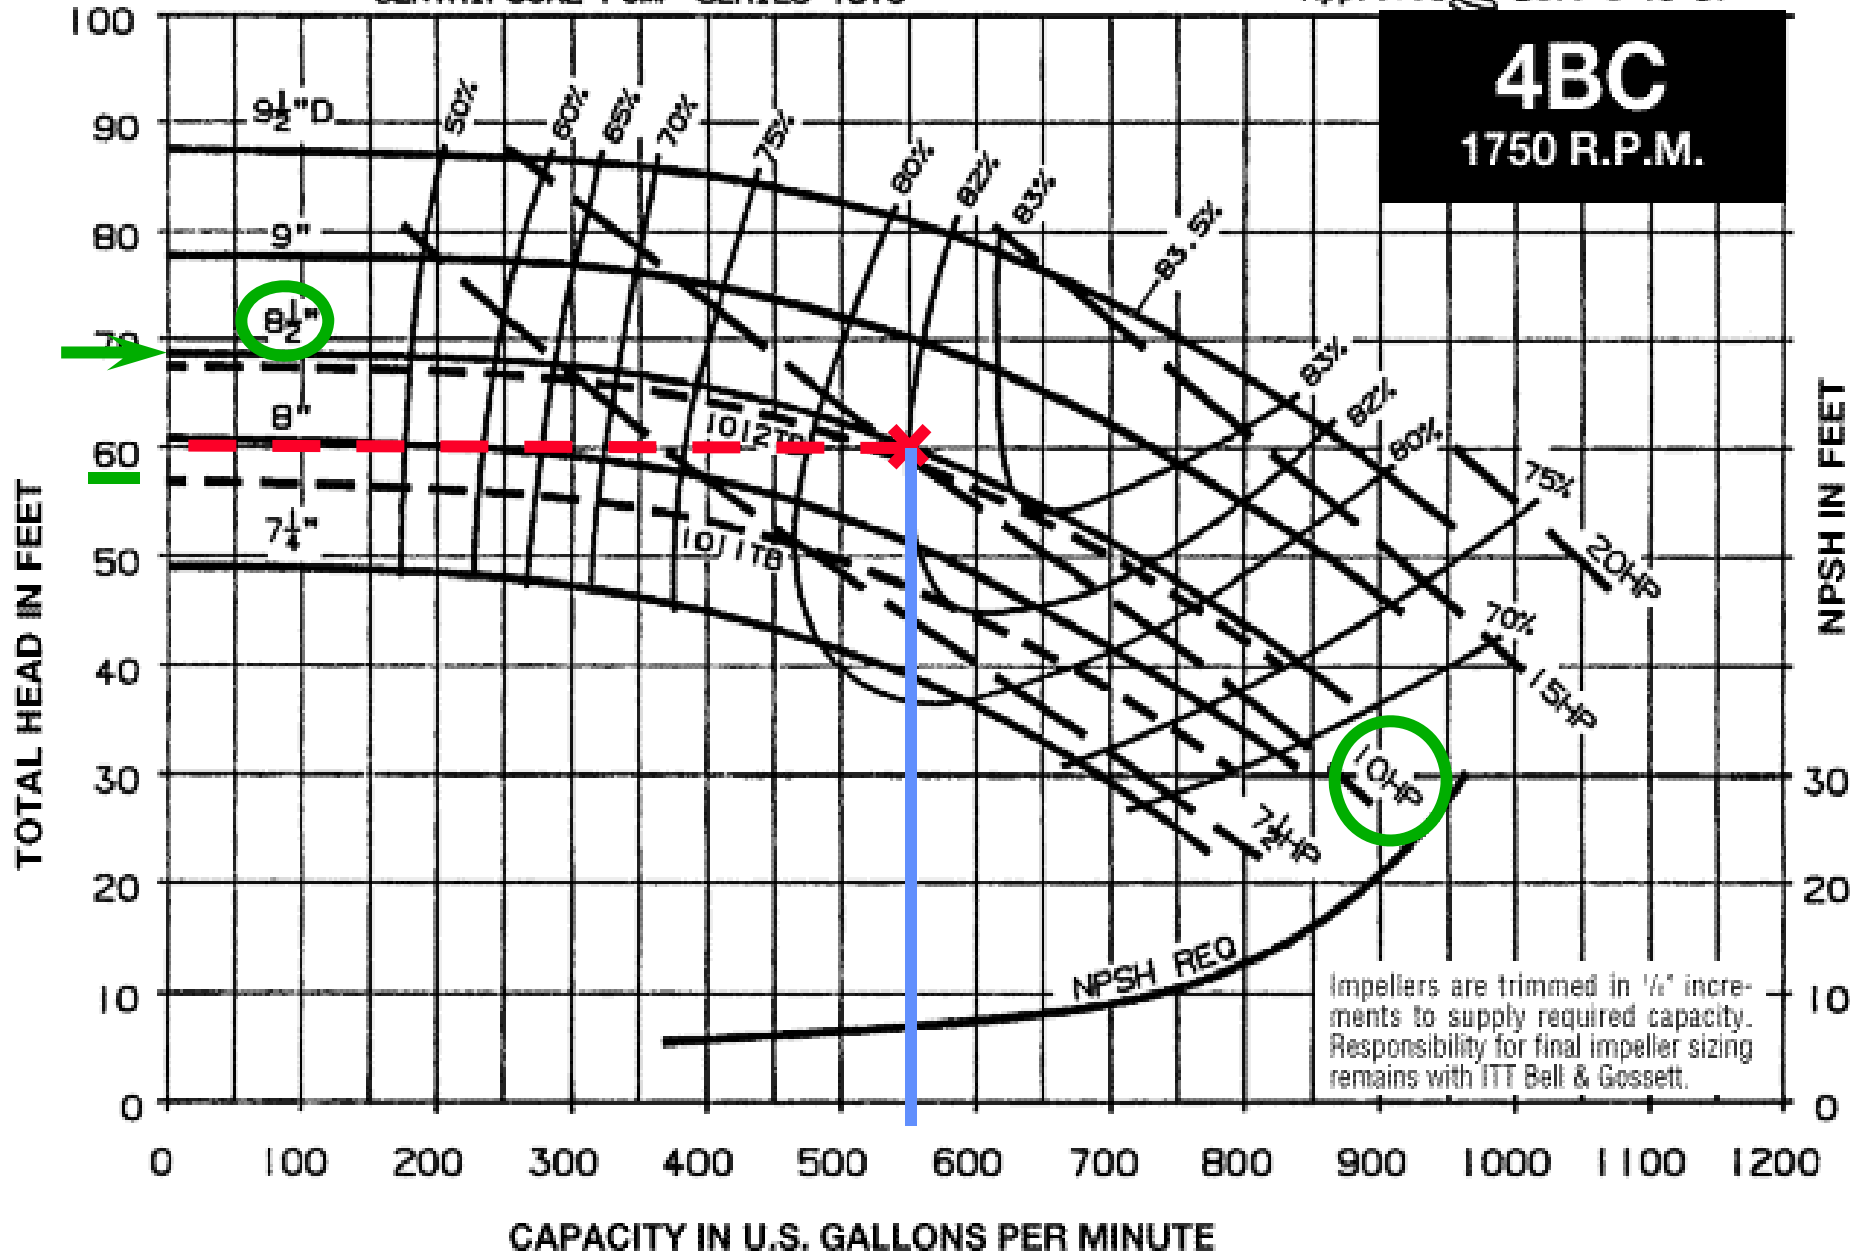
CENTRIFUGAL PUMP SERIES 1510

Convert to ft.:  $29.5\text{psi} \times 2.31\text{ft/psi} = 68\text{ft}$

Impeller Size	<u>8-1/2"</u>
Flow Rate	<u>550 GPM</u>
Horsepower	<u>10</u>
NOL	<u>15</u>

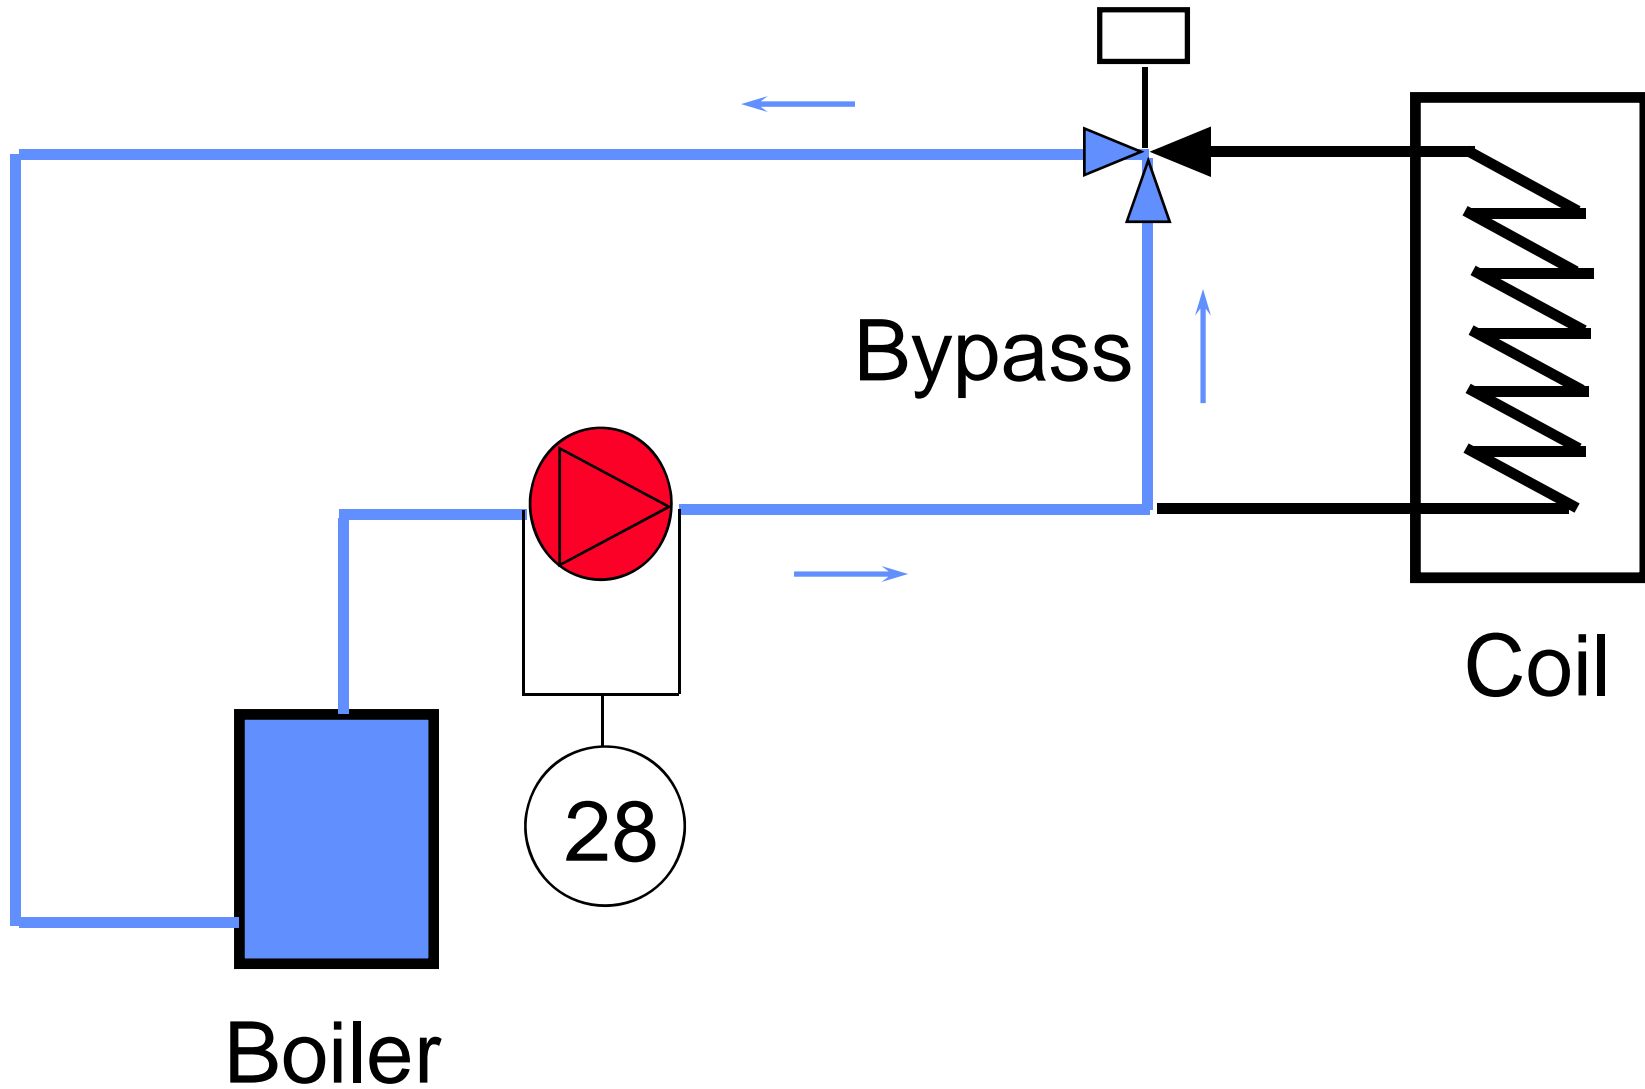
# Problem 3 - Bypass

When the 3-way valve is open to bypass, the PD is 28 psi.

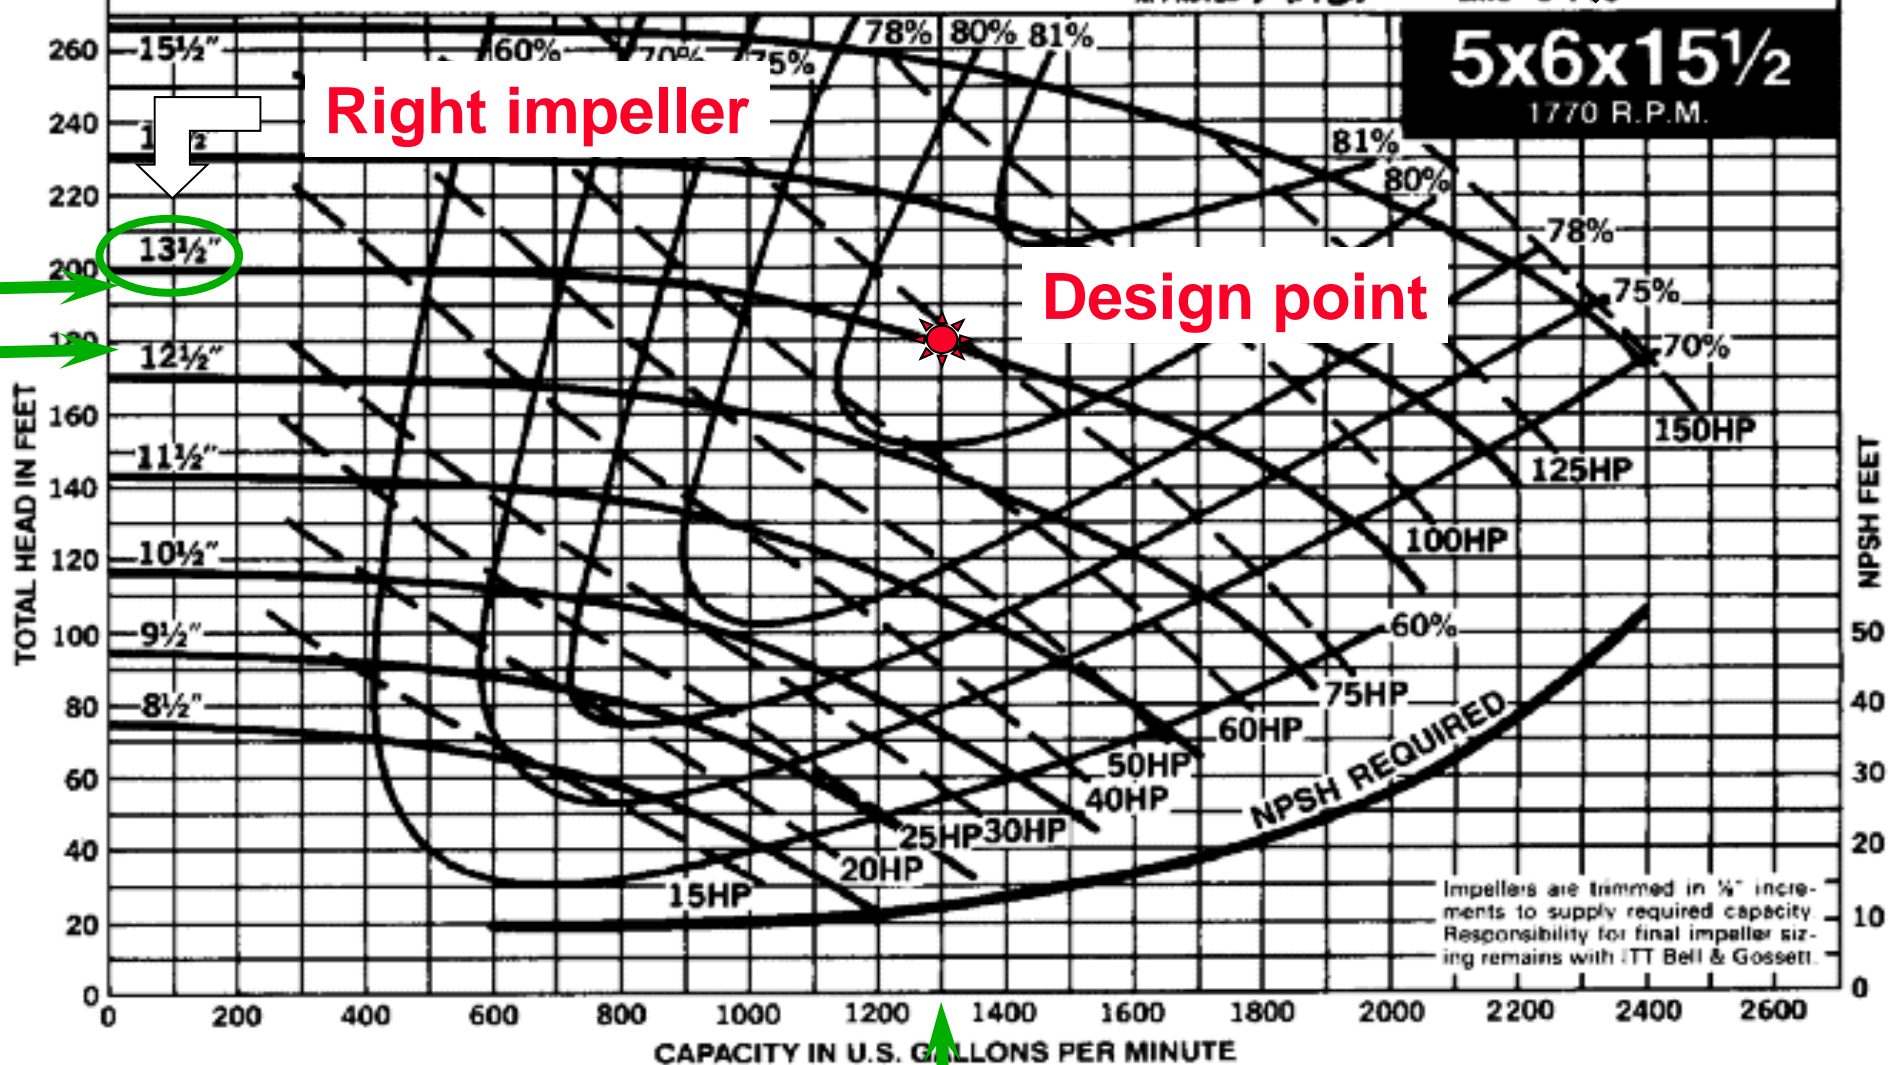
PERFORMANCE CHARACTERISTIC CURVE

Your PD = 86psi. (116 - 30)

Converting to ft:  $86\text{psi} \times 2.31\text{ft/psi} = 199'$

CURVES BASED ON SHOP TEST USING CLEAR COLD WATER AT A TEMPERATURE OF NOT OVER 85°F. PERFORMANCE IS GUARANTEED AT INDICATED OPERATING POINT ONLY.

Right pump

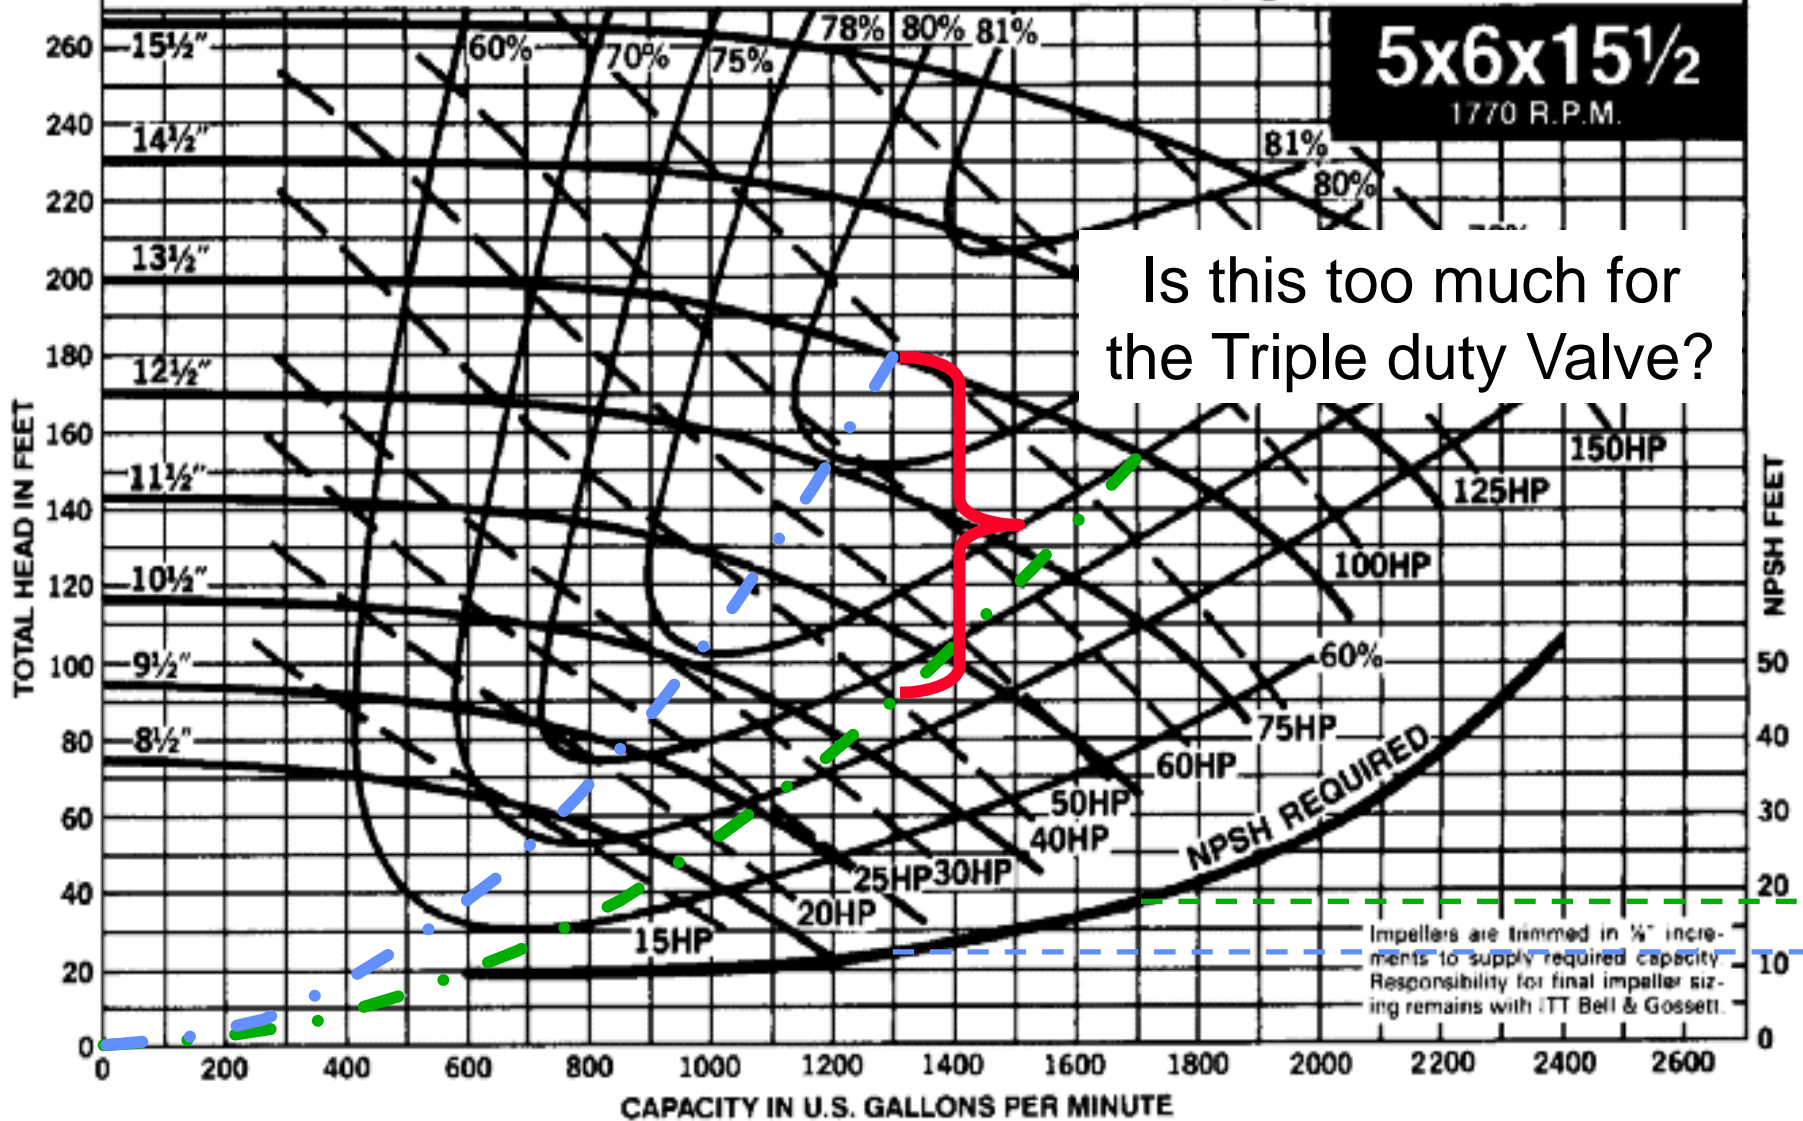
PERFORMANCE CHARACTERISTIC CURVE

- Close down on the 3D Valve
  - May substitute one problem for another
  - May damage the valve
- Trim impeller, then throttle 3D Valve
- Any other ideas?
