VSD Modification to Inhibit Motor Bearing Fluting (revised April 2009)

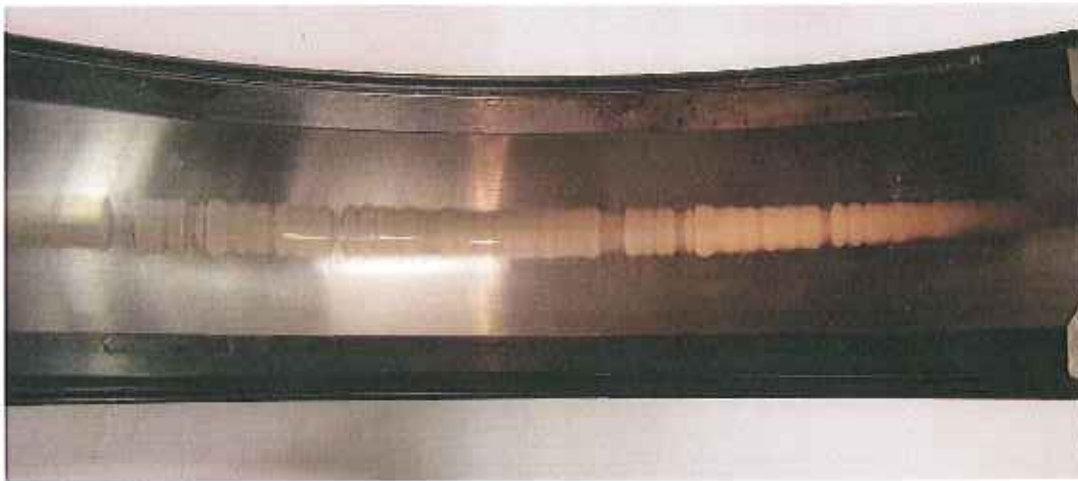
“Bearing Fluting” is a term used to describe deterioration in a motor bearing due to electrical currents passing through the bearing, causing electrical discharge on the wear path of the bearing. This phenomenon creates a characteristic washboard appearance in the bearing wear path and is evidenced by higher than normal vibration and a rumbling sound, especially noticeable during coast down.

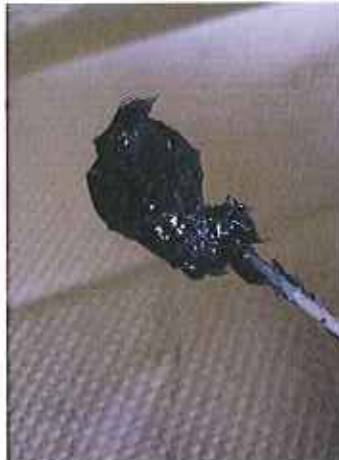
condition of the bearing grease. Do this by removing the grease relief port pipe-plug, and inserting a white nylon wire-tie up into the relief port. Whip the wire-tie around to get a sample of grease on the end, and then withdraw the wire-tie to examine the condition of the grease. Bearings that have been fluted will exhibit blackened grease having normal grease consistency, looking wet and shiny, although black in color. This appearance differs from grease that is just worn out, which looks blackened - but gritty and dry, like charcoal.

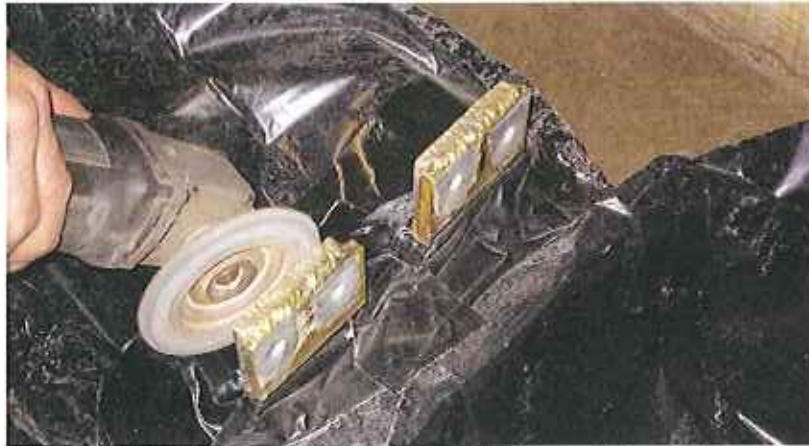
Plastic Bag and Tape keeps dirt out of Inductor

- 7- Position the 1L inductor on the floor with the shorting bar pointed upward. Cut a slit in the large plastic bag, and place this slit down over the bus bars, using tape to seal the slit against the bus bars. This will prevent metal filings from getting down into the coils of the inductor.

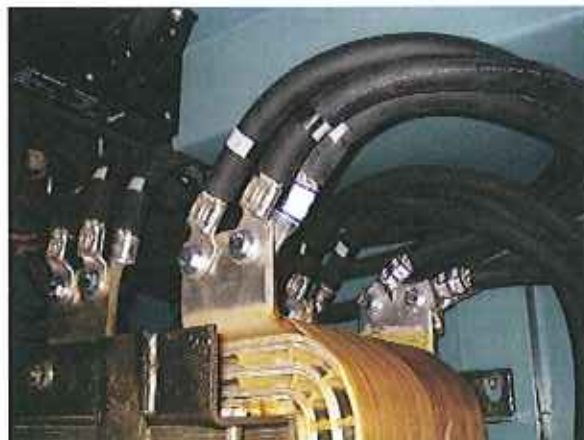
Modified 1L Inductor is Moved into Position

- 11- Clean up the surface to remove any burrs or sharp edges using a file or suitable tool.
- 12- Carefully remove the duct tape and plastic bag, making certain none of the metal filings drop down into the coils of the inductor.
- 13- Re-install the 1L inductor into the VSD cabinet using the sling and come-a-long.
- 14- Position the 1L inductor with the bus bars facing the rear of the cabinet as before. Do not fasten the inductor to the cabinet floor at this time, so that the inductor can be moved slightly to help with access to the lugs.
- 15- Connect existing wires 208 B/C/D from the positive side of the rectifiers to the upper left bus bar (viewed from open cabinet door). This is the same bus bar as originally connected to these wires.

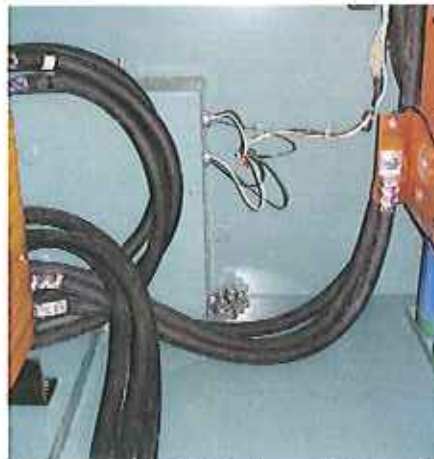
New Wires are added between 1L and DC bus

17- Remove the negative bus wires 209 A/B/C from the laminated bus on the pole assemblies. Bend these wires back toward the 1L inductor. The two bottom wires will be the correct length to reach the upper right lug on 1L. The third wire from the laminated bus will be about 24" longer. Just loop this wire back and attach together with the other two to the same lug at the upper right side of 1L. (The third wire in the photo below was cut back and re-lugged)

18- Install three new wires (no wire number) from the lower right bus bar of 1L to the negative side of the laminated bus on the inverter poles. Use Alcoa EJC#2 again as with the other lower lug. The two shorter wires go to the bottom laminated bus connection, the single longer wire goes to the upper connection on the laminated bus.

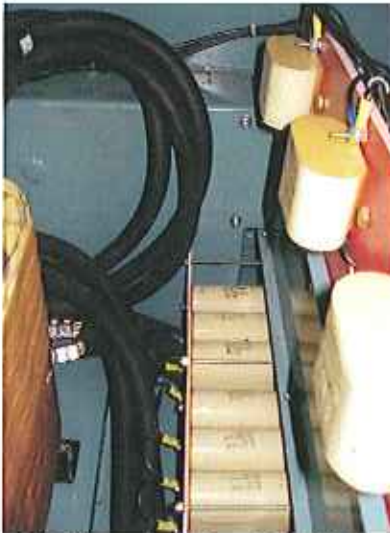
The 20 kHz Trap is re-installed into the VSD

20- If the unit includes the IEEE-519 filter option, at this time re-connect wires 517, 518, and 519. Also, reinstall the 20 kHz trap assembly. Make certain the wires from the 1L inductor to

the laminated bus are not pierced or cut by any hardware along the bottom of the 20 kHz trap. Use wire ties to secure the power conductors.
