# Service Information

SI0229

Equipment Affected: AIR COOLED CHILLERS

PROCEDURES TO FOLLOW WHEN REMOVING A DEFECTIVE THERMAL EXPANSION VALVE (TXV)

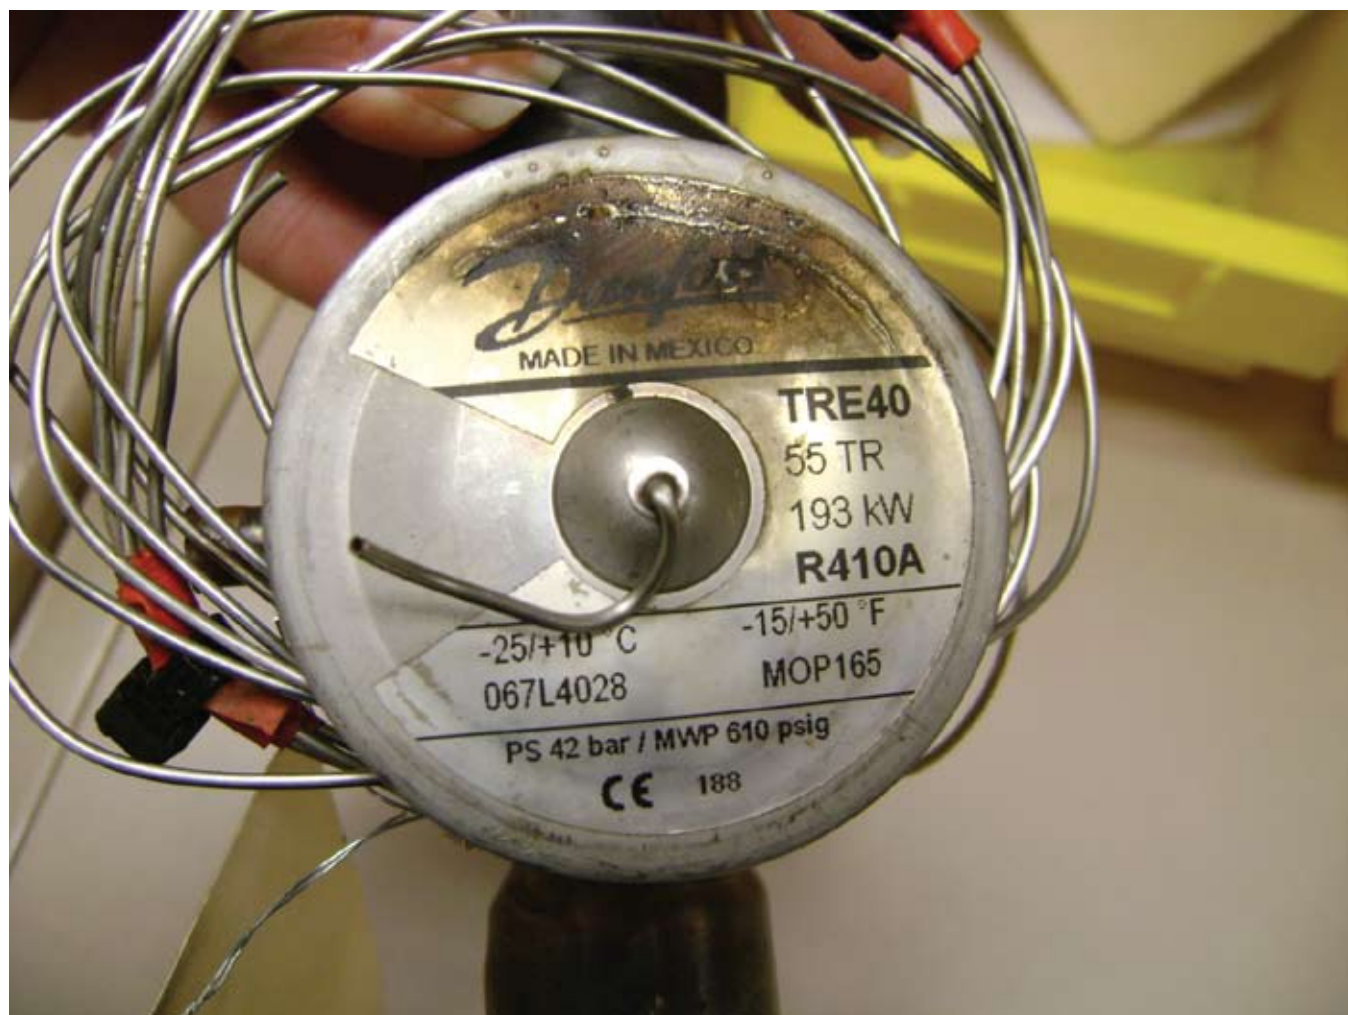
LD14677

Below are some examples of capillary tubes that were broken due to heat contact during the valve removal process. Evidence of heating from the torch flame on the power head is visible.

When removing thermal expansion valves with stainless steel capillary tubes, be very careful to ensure the capillary tube is positioned away from the torch flame. Unstrap the bulb and capillary tube from the piping and coil it near the power element before beginning. Move the coiled cap tube from side to side or up and down as needed to avoid flame contact when unbrazing the inlet and outlet connections. Use a small heat shield whenever possible to cover the cap tube and the power head. Since stainless steel is much more resistant to breakage from flexing than copper cause it to break during the unbrazing of the valve.
