## Report of Eddy Current Inspection

Manufacturer: Carrier

Model: 17DA743

Location: DUPONT EXPERIMENTAL STATION  
RTE. 141 BETWEEN 52 & 202  
WILMINGTON, DE 19735

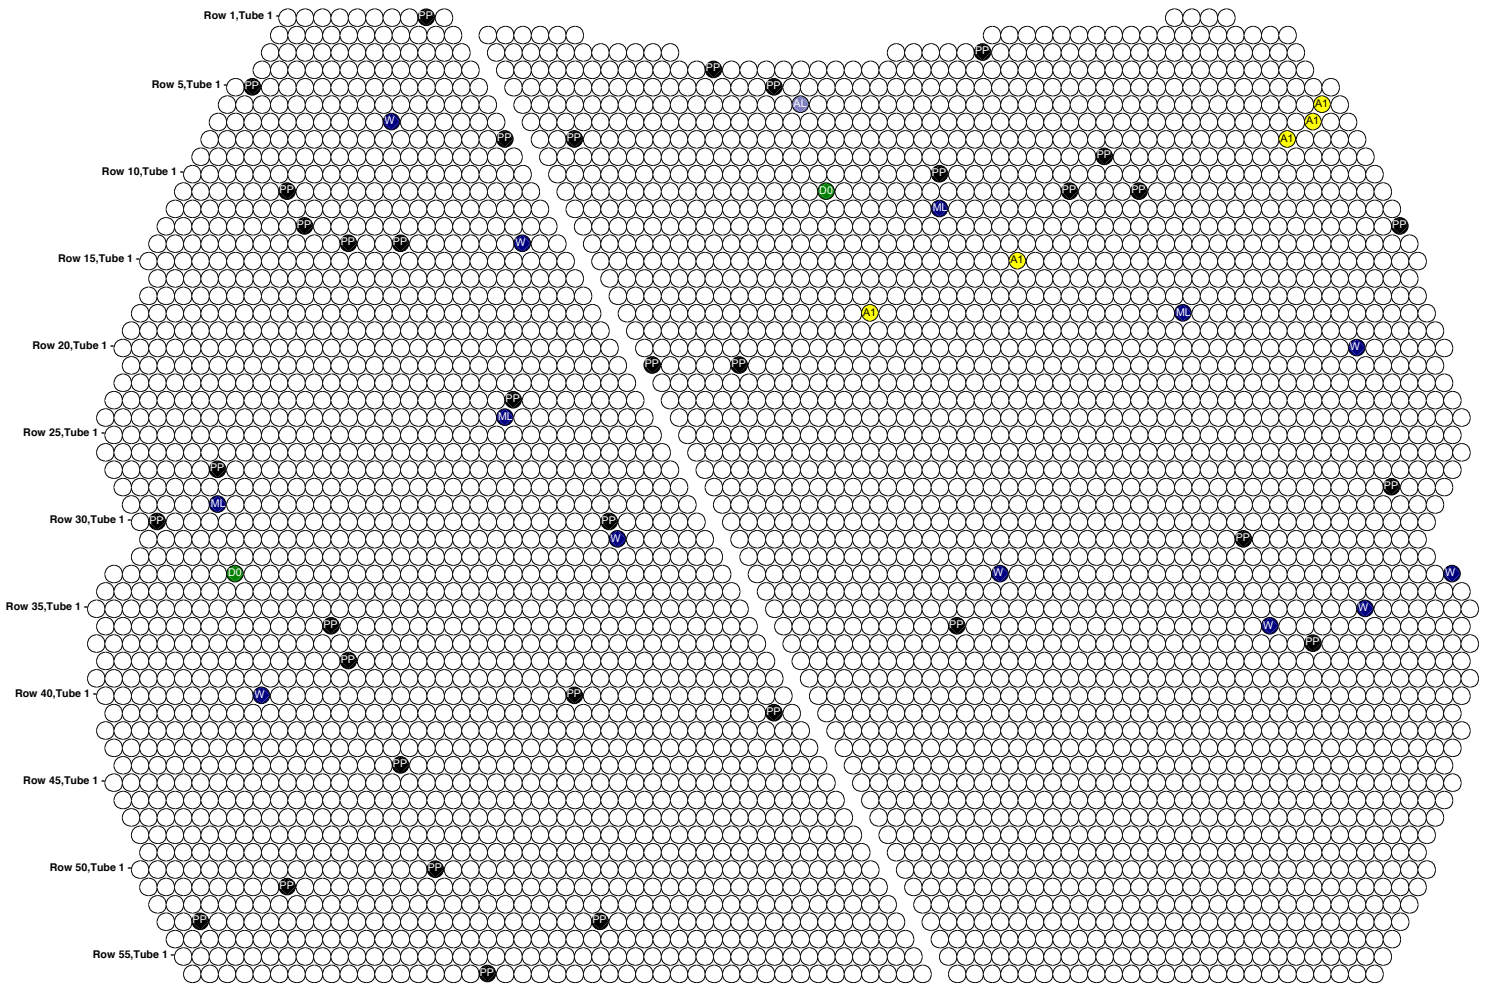
Condenser: 3990 Tubes		
Tubes Tested: 3990 Tubes		
Significant/Measurable Indications	Number of Tubes Marked	Percent of Bundle
ABN. NOMINAL BELL/ROLL	5	.13
ABN SUPPORT LANDING	1	.03
OD DEFECT < 20%	2	.05
MISSING LAND	4	.10
PREVIOUSLY PLUGGED	36	.90
DIFF WALL THICKNESS	9	.23
<b>Totals</b>	<b>57</b>	<b>1.44</b>

NOTE: Although not marked, the majority of tubes gave indications of minor generalized ID Corrosion and Pitting. No individual tubes gave indications of significant damage, and therefore none were marked.

The tubes indicating Abnormal Bell End Indications require no corrective action at this time. The indications are that of thinning at the Bell End. The exact cause and description of the anomaly is unknown. However, it is believed to be a non-progressive manufacturing anomaly and should not affect the performance or longevity of the effected tubes.

The tube indicating Abnormal Support Landing Indications requires no corrective action at this time. This tube showed a distorted transition zone at the indicated support. The exact cause of the indication is unknown, but is believed to be the result of manufacturing.

The OD Defects detected appear minor at this time, and require no immediate corrective action. However, the damage mechanism and growth rates are unknown.

Tubes missing support landings showed no detectable loss and require no corrective action.

The tube(s) marked as "Different Wall Thickness" were .750/.045/.028 tubes of the same alloy. These tubes were inspected without re-calibrating the test instrument. No measurable indications of tube damage and were identified.

It was noted during the inspection that the tubes contained a moderate amount of what appeared to be lime calcium scale build-up. Consideration should be given to chemically cleaning these tubes to prevent internal tube wall damage and promote heat transfer.

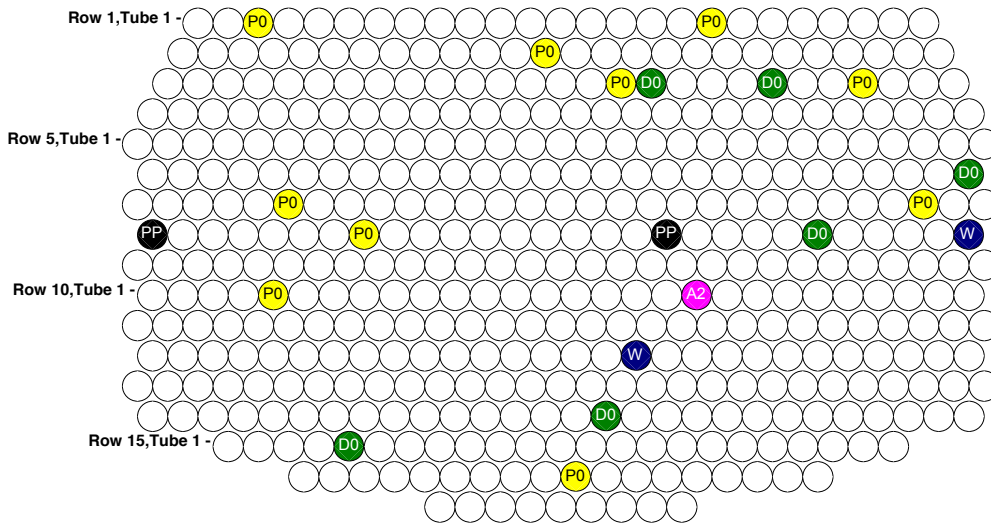
# Sub-Cooler Section

Sub-Cooler: 441 Tubes		
Tubes Tested: 441 Tubes		
Significant/Measurable Indications	Number of Tubes Marked	Percent of Bundle
ABN. EXCESS. BELL/ROLL*	1	.23
OD DEFECT < 20%	6	1.36
ID PIT < 20%	10	2.27

NOTE: Although not marked, the majority of tubes gave indications of minor generalized ID Corrosion. No individual tubes gave indications of significant damage, and therefore none were marked.

The OD Defects detected appear minor at this time, and require no immediate corrective action. However, the damage mechanism and growth rates are unknown.

We recommend the tube indicating an Abnormal Bell End Indication be isolated from the system at this time. The exact cause of the indication is unknown. However, excessive thinning is indicated.
