## Report of Eddy Current Inspection

Manufacturer: Carrier

Model: 17DA743

Location: DUPONT EXPERIMENTAL STATION  
200 POWER MILL ROAD  
BUILDING 315  
WILMINGTON, DE 19803

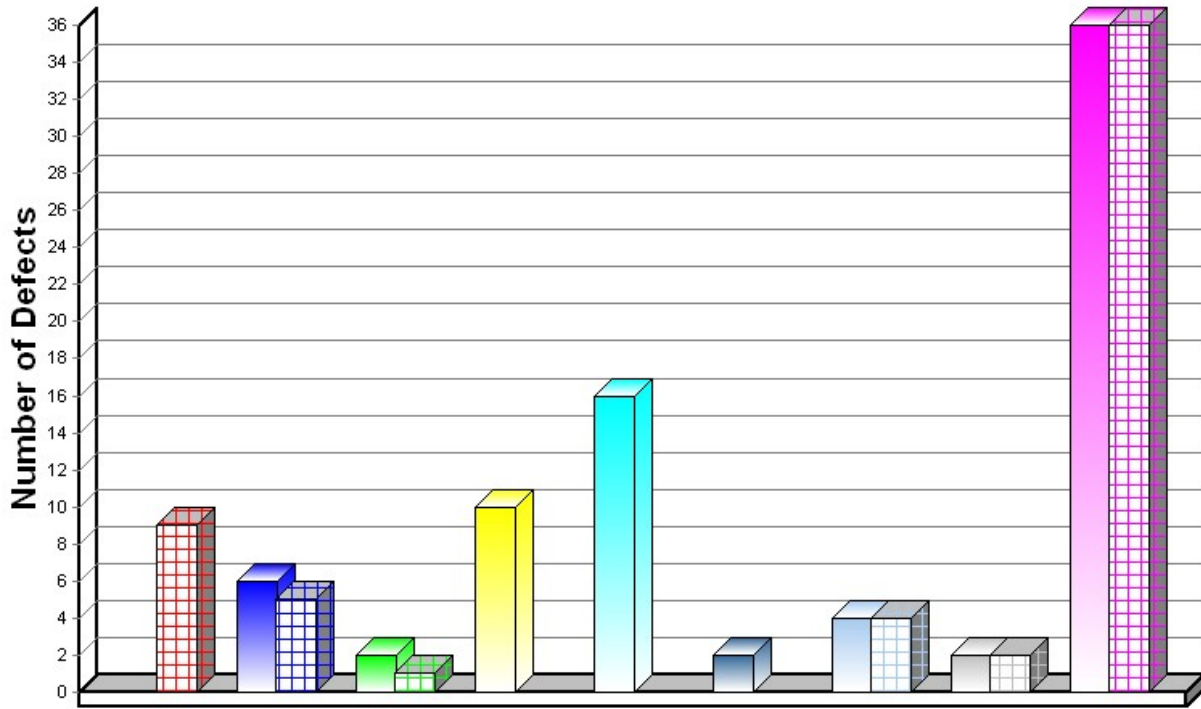
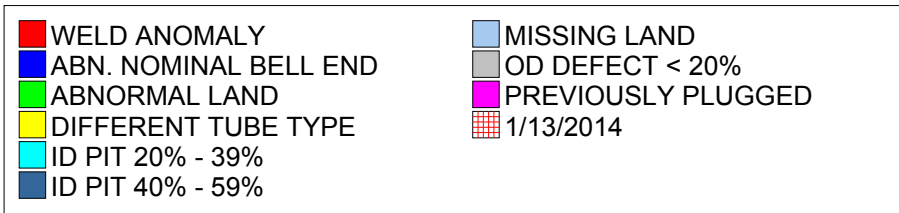
### Condenser Defects

Condenser: 3990 Tubes		
Tubes Tested: 3990 Tubes		
Significant/Measurable Indications	Tubes Marked	Percent of Bundle
ABN. NOMINAL BELL END	6	.15
ABNORMAL LAND	2	.05
OD DEFECT < 20%	2	.05
DIFFERENT TUBE TYPE	10	.25
MISSING LAND	4	.10
ID PIT 20% - 39%	16	.40
ID PIT 40% - 59%*	2	.05
PREVIOUSLY PLUGGED	36	.90
<b>Totals</b>	<b>78</b>	<b>1.95</b>

NOTE: Although not marked, the majority of tubes gave indications of minor generalized ID Corrosion and Pitting. Only those tubes giving indications greater than 20% or more were marked in order to keep the tube chart neat and legible and to better illustrate more critical damage.

Tubes indicating Abnormal Bell End Indications require no corrective action at this time. The indications are that of minor thinning at the Bell End. The exact cause and description of the anomaly is unknown.

Tubes indicating Abnormal Support Landings require no corrective action at this time. These tubes showed a distorted transition zone at the indicated support. The exact cause of the indication is unknown, but is believed to be the result of manufacturing.

The tubes marked for OD Defects require no corrective action at this time.

The tube(s) marked as "Different Tube Type" were .750/.042/.028 CuNi tubes. The test instrument was calibrated, and standard procedures were followed for this tube type and alloy. These tubes showed no measurable indications of tube damage and were marked for information purposes only.

The tubes missing support landings showed no detectable damage or loss and require no corrective action.

Tubes indicating ID Pits of 40% or more should be isolated from the system at this time. ID Pits of less than 40% require no immediate corrective action. However, this type damage is usually progressive and should be monitored.

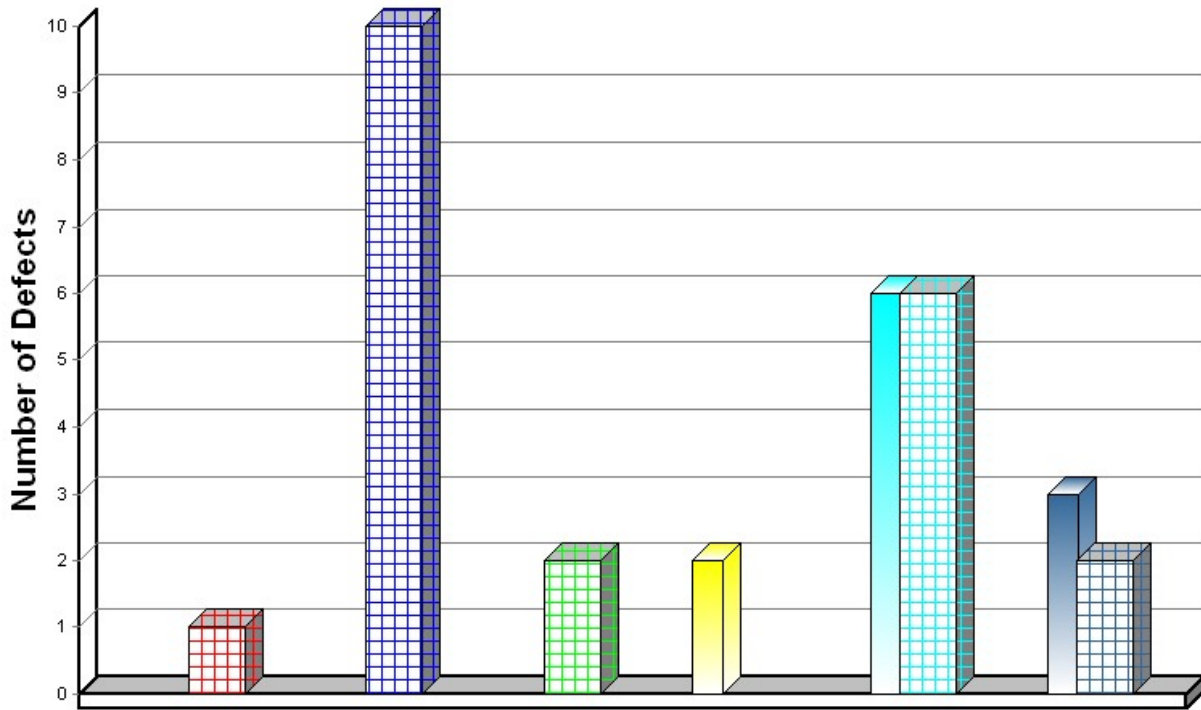
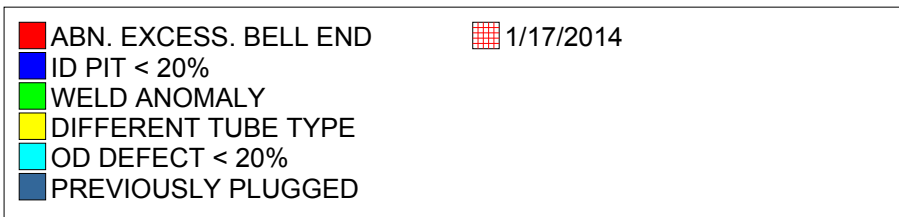
### Sub-Cooler Defects

Sub-Cooler: 441 Tubes		
Tubes Tested: 441 Tubes		
Significant/Measurable Indications	Tubes Marked	Percent of Bundle
OD DEFECT < 20%	6	1.36

NOTE: Although not marked, all the tubes in this bundle gave indications of minor generalized ID Corrosion and ID Pitting. No individual tubes gave indications of significant damage, and therefore none were marked.

The tubes marked for OD Defects require no corrective action at this time.

The tube(s) marked as "Different Tube Type" were .750/.042/.028 CuNi tubes. The test instrument was calibrated, and standard procedures were followed for this tube type and alloy. These tubes showed no measurable indications of tube damage and were marked for information purposes only.
