Report of Eddy Current Inspection

Manufacturer: Carrier

Model: 17DA743

Location: DUPONT EXPERIMENTAL STATION
200 POWER MILL ROAD
BUILDING 315
WILMINGTON, DE 19803

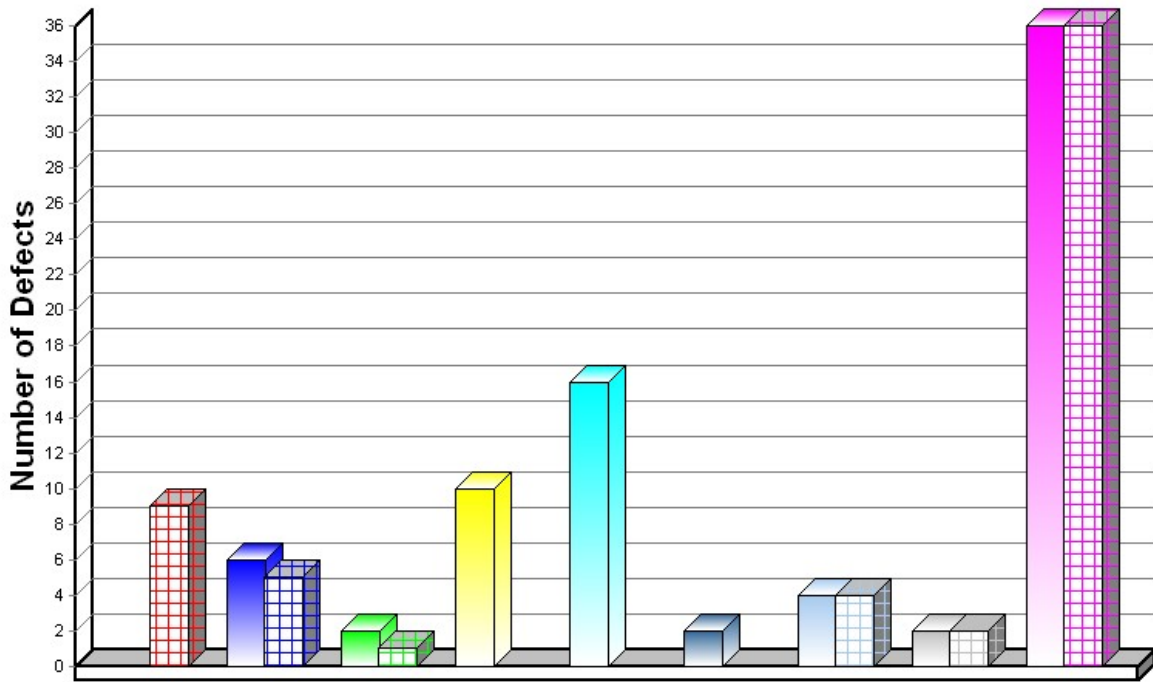
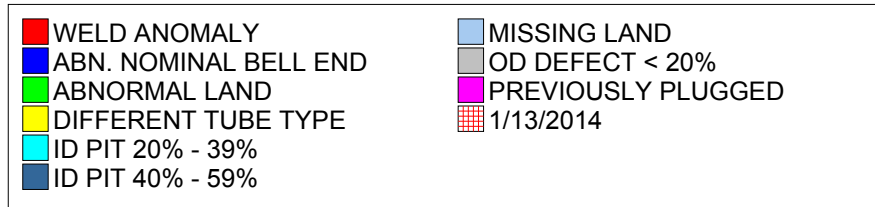
Condenser Defects

Condenser: 3990 Tubes		
Tubes Tested: 3990 Tubes		
Significant/Measurable Indications	Tubes Marked	Percent of Bundle
ABN. NOMINAL BELL END	6	.15
ABNORMAL LAND	2	.05
OD DEFECT < 20%	2	.05
DIFFERENT TUBE TYPE	10	.25
MISSING LAND	4	.10
ID PIT 20% - 39%	16	.40
ID PIT 40% - 59%*	2	.05
PREVIOUSLY PLUGGED	36	.90
Totals	78	1.95

NOTE: Although not marked, the majority of tubes gave indications of minor generalized ID Corrosion and Pitting. Only those tubes giving indications greater than 20% or more were marked in order to keep the tube chart neat and legible and to better illustrate more critical damage.

Tubes indicating Abnormal Bell End Indications require no corrective action at this time. The indications are that of minor thinning at the Bell End. The exact cause and description of the anomaly is unknown.

Tubes indicating Abnormal Support Landings require no corrective action at this time. These tubes showed a distorted transition zone at the indicated support. The exact cause of the indication is unknown, but is believed to be the result of manufacturing.

The tubes marked for OD Defects require no corrective action at this time.

The tube(s) marked as "Different Tube Type" were .750/.042/.028 CuNi tubes. The test instrument was calibrated, and standard procedures were followed for this tube type and alloy. These tubes showed no measurable indications of tube damage and were marked for information purposes only.

The tubes missing support landings showed no detectable damage or loss and require no corrective action.

Tubes indicating ID Pits of 40% or more should be isolated from the system at this time. ID Pits of less than 40% require no immediate corrective action. However, this type damage is usually progressive and should be monitored.

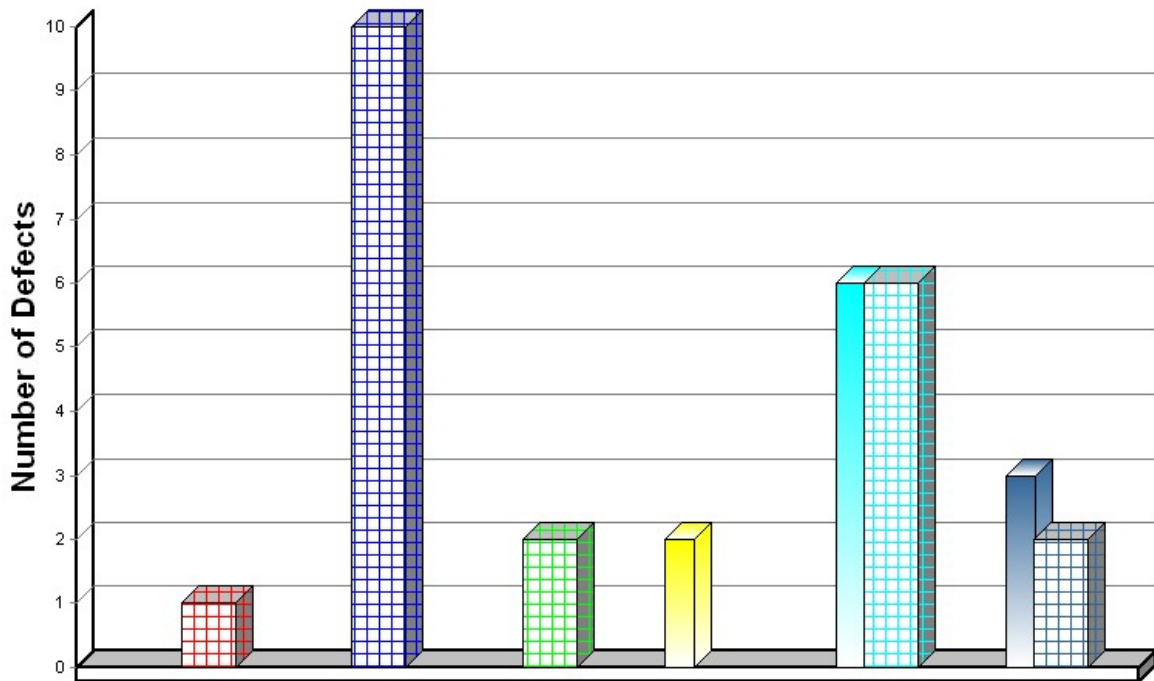
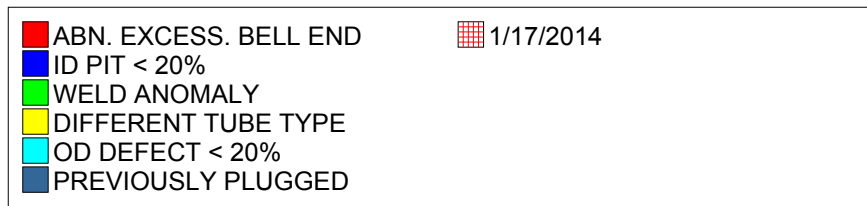
Sub-Cooler Defects

Sub-Cooler: 441 Tubes		
Tubes Tested: 441 Tubes		
Significant/Measurable Indications	Tubes Marked	Percent of Bundle
OD DEFECT < 20%	6	1.36

NOTE: Although not marked, all the tubes in this bundle gave indications of minor generalized ID Corrosion and ID Pitting. No individual tubes gave indications of significant damage, and therefore none were marked.

The tubes marked for OD Defects require no corrective action at this time.

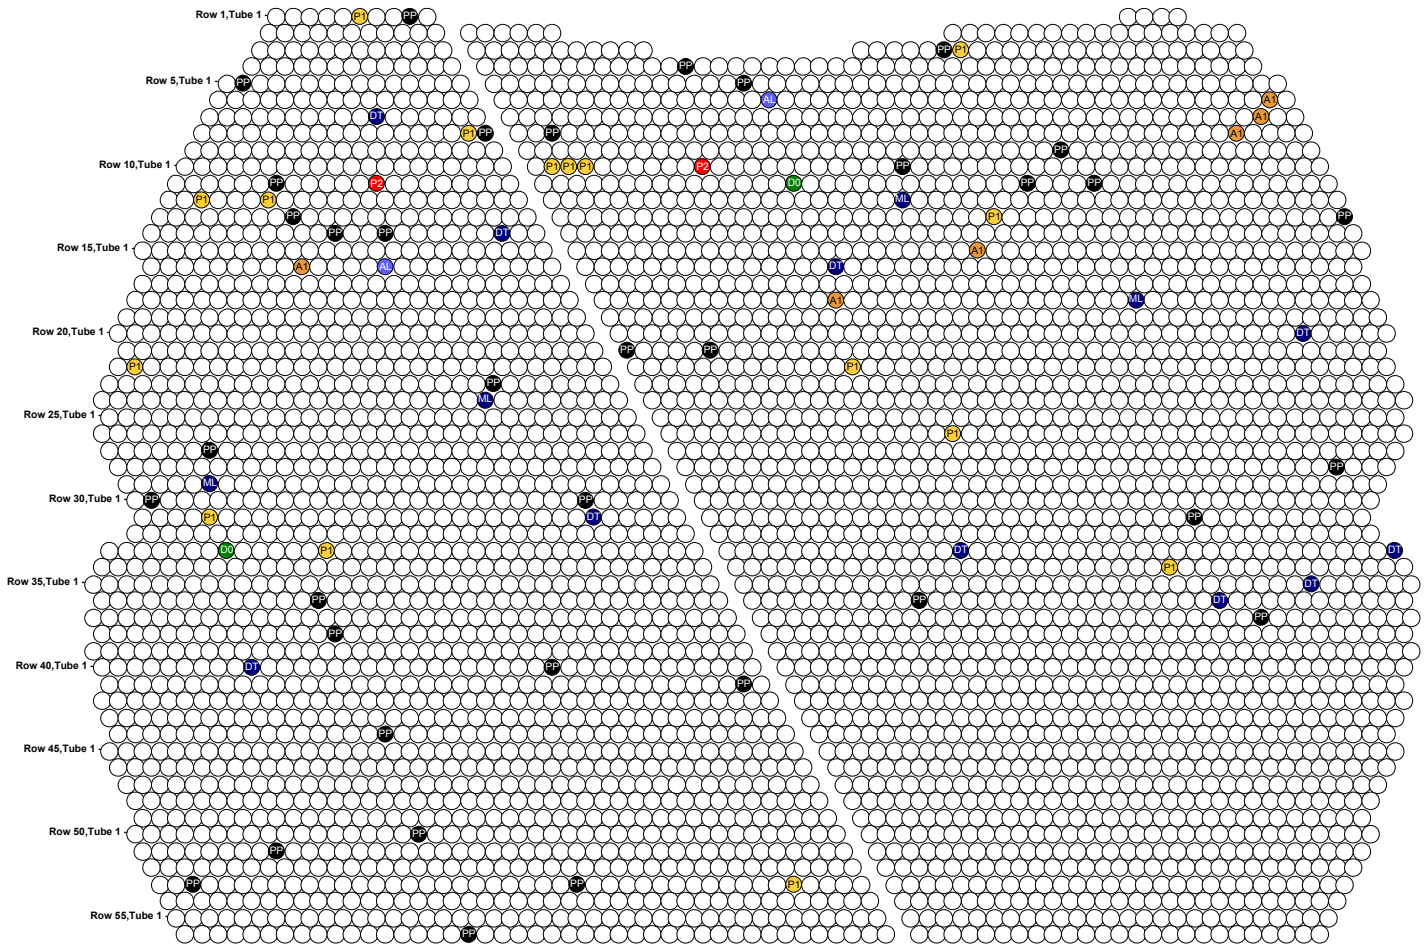
Row	Tube	Description	Area	Action Req.
9	52	PREVIOUSLY PLUGGED	TE	
10	22	ID PIT 20% - 39%	B04	
10	23	ID PIT 20% - 39%	B02	
10	24	ID PIT 20% - 39%	B04	
10	31	ID PIT 40% - 59% Plugged by JCI - 12/21/2018	B04	✓
10	43	PREVIOUSLY PLUGGED	TE	
11	7	PREVIOUSLY PLUGGED	TE	
11	13	ID PIT 40% - 59% Plugged by JCI - 12/21/2018	B05	✓
11	37	OD DEFECT < 20%	B01	
11	51	PREVIOUSLY PLUGGED	TE	
11	55	PREVIOUSLY PLUGGED	TE	
12	3	ID PIT 20% - 39%	B03	
12	7	ID PIT 20% - 39%	B05	
12	44	MISSING LAND	S02	
13	9	PREVIOUSLY PLUGGED	TE	
13	50	ID PIT 20% - 39%	B02	
13	71	PREVIOUSLY PLUGGED	TE	
14	12	PREVIOUSLY PLUGGED	TE	
14	15	PREVIOUSLY PLUGGED	TE	
14	22	DIFFERENT TUBE TYPE	TE	
15	50	ABN. NOMINAL BELL END	OTE	
16	10	ABN. NOMINAL BELL END	OTE	
16	15	ABNORMAL LAND	S03	
16	41	DIFFERENT TUBE TYPE	TE	
18	42	ABN. NOMINAL BELL END	OTE	
18	60	MISSING LAND	S04

Row	Tube	Description	Area	Action Req.
20	71	DIFFERENT TUBE TYPE	TE	
21	30	PREVIOUSLY PLUGGED	TE	
21	35	PREVIOUSLY PLUGGED	TE	
22	2	ID PIT 20% - 39%	B03	
22	44	ID PIT 20% - 39%	B01	
23	24	PREVIOUSLY PLUGGED	TE	
24	24	MISSING LAND	S02	
26	51	ID PIT 20% - 39%	B04	
27	7	PREVIOUSLY PLUGGED	TE	
28	73	PREVIOUSLY PLUGGED	TE	
29	6	MISSING LAND	S02	
30	2	PREVIOUSLY PLUGGED	TE	
30	28	PREVIOUSLY PLUGGED	TE	
31	5	ID PIT 20% - 39%	B03	
31	28	DIFFERENT TUBE TYPE	TE	
31	63	PREVIOUSLY PLUGGED	TE	
33	8	OD DEFECT < 20%	B04	
33	14	ID PIT 20% - 39%	B05	
33	51	DIFFERENT TUBE TYPE	TE	
33	77	DIFFERENT TUBE TYPE	TE	
34	64	ID PIT 20% - 39%	B04	
35	73	DIFFERENT TUBE TYPE	TE	
36	14	PREVIOUSLY PLUGGED	TE	
36	49	PREVIOUSLY PLUGGED	TE	
36	67	DIFFERENT TUBE TYPE	TE	
37	70	PREVIOUSLY PLUGGED	TE
