## Report of Eddy Current Inspection

Manufacturer: York

Model: OTT4G2-ZBES

Serial: GACM117864 #8

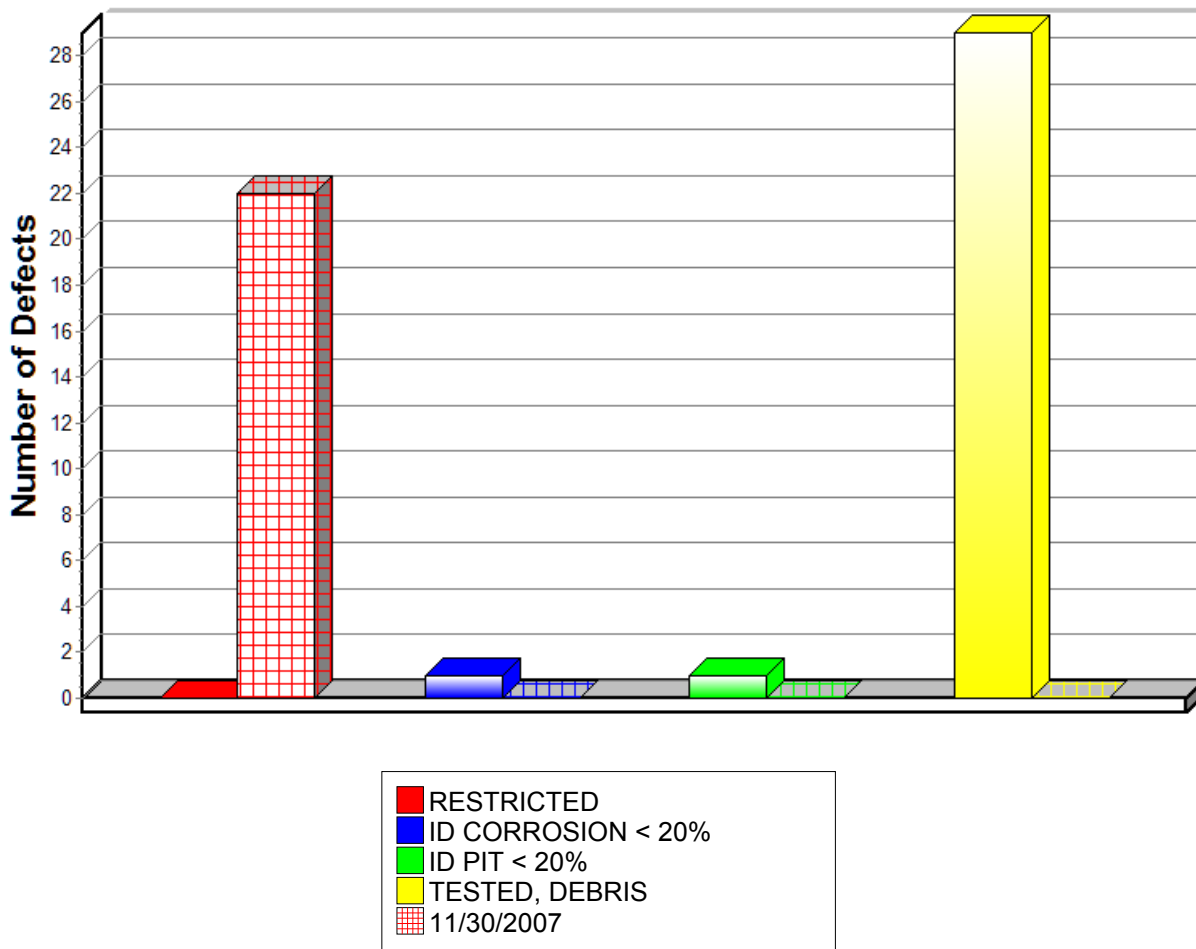
### Condenser Defects

Condenser: 883 Tubes		
Tubes Tested: 883 Tubes		
Significant/Measurable Indications	Number of Tubes Marked	Percent of Bundle
ID CORROSION < 20%	1	.11
ID PIT < 20%	1	.11
TESTED, DEBRIS	29	3.28
<b>Totals</b>	<b>31</b>	<b>3.50</b>
