Date: 8/23/76
From: CHARLES D. MILLER
Office: MSD SERVICE ENGINEERING, SYRACUSE
Subject: SADDLE DAMAGE TO COOLER TUBES
FIELD EXPERIENCE REPORT 76-5

"Saddle Damage of Cooler Tubes"

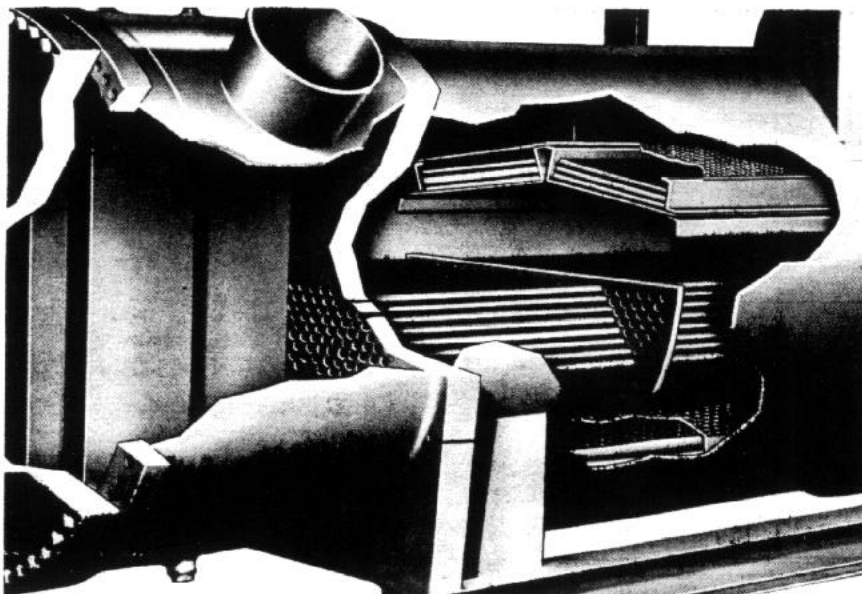
The cooler consists of a cylindrical mild steel shell with a bundle of copper tubes occupying the bottom half of the shell. These tubes are supported periodically along their length with mild steel tube support sheets (Fig. 3). These copper tubes are usually of the integral fin type. Such a tube is made from a blank tube from the O.D. surface of which are extruded integral fins resembling screw threads. The finning is discontinued at the tube sheet and

Fig. 3. Cooler section showing tubes and tube support sheet
