• SUBJECT: 19EA OIL LOSS

F.E.R. 77-5

19EA OIL LOSS

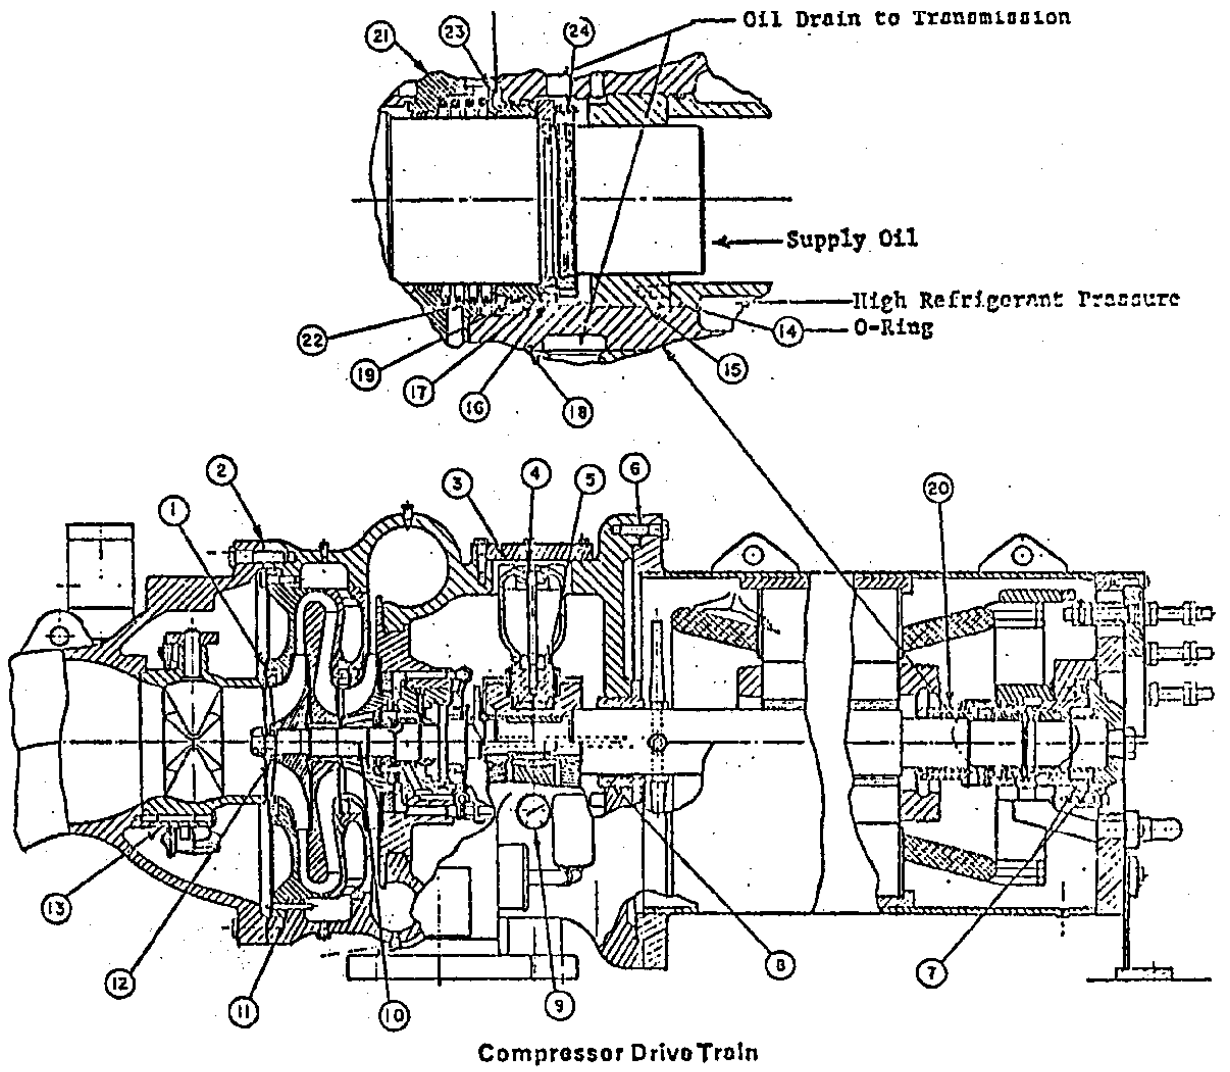
Rear Carbon Seal
Fig. 7

4.1 Leakage at the motor end carbon is not likely in a running condition since there is little pressure drop across the seal. At start-up, however, oil can be lost if the rear carbon is worn. Inspect and replace the seal if necessary. Check for binding of O-Ring (ITEM 19, FIGURE 7) against the seal ring by depressing seal ring against spring. Lubrication of O.D. of carbon ring will usually eliminate binding.

4.2 Motor cooling refrigerant may be mixing with the oil due to a bad O-Ring joint (ITEM 14, FIGURE 7). This will cause continuous oil foaming and low oil temperatures.
