## SERVICE BULLETIN

**Title:** 17/19EX Sticking Float Valves  
**Models Affected:** 17/19EX

**Number:** C9724  
**Date:** 8/8/97  
**Supersedes:** New

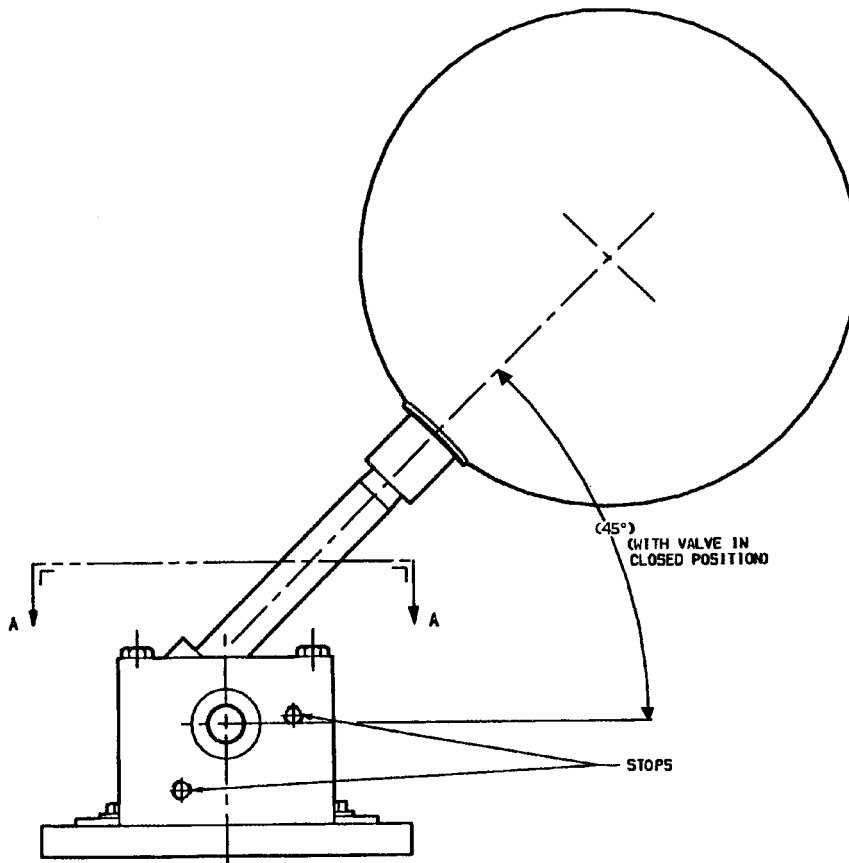
**Figure 1**  
**Float Assembly**

There have been several reports from the field of low cooler pressure alarms on 17/19EX machines. In most cases, this phenomenon has been traced to a stuck float valve in the economizer. The problem can be attributed to the steel plate that the float valve mounts to in the economizer warping during the welding process (See Figures 5 and 6). This causes the float's mounting plate to twist slightly, and the bearings to bind.

When lifted by hand, the float ball should move freely throughout its range of motion. If the float ball does not move freely, check to be sure that the float's shim plates are not binding against the float's swing plate. The recommended factory clearances are shown in Figures 2 and 3. Once assembled, the valve should rotate throughout its range of motion with a minimum clearance between the swing plate and the shim plate of  $0.060 \pm 0.005$  inches ( $1.5 \pm 0.1$  mm). It is easier to check the clearances from the under side of the float assembly.

If this did not remedy the problem, loosen slightly one of the four mounting bolts, and re-check the operation of the float ball. If loosening one bolt did not correct the problem, re-tighten it and loosen another bolt. Repeat the procedure until the float moves freely. If the plate is warped, loosening one bolt will rectify the problem. The deformation caused by the warped mounting plate will not be transmitted to the valve's bearing blocks with three bolts anchoring the valve plate. It is recommended that the loosened bolt be re-installed with Loctite 54 to prevent it from backing out. The loosened bolt should not be tightened to the original torque. Once the bolt has been reinstalled with the Loctite, re-check the operation of the float ball.

The factory has implemented a practice to check the valves for free valve travel after assembly. If the float ball is not allowing the valve to open, check for a leak in the float ball. If a leak in the float ball is suspected, it can be checked by submerging the float ball in a bath of hot water. Heating the ball in the hot water bath will cause the trapped refrigerant inside of the ball to expand and escape through the leak path. If a leak is found, replace the ball.
