# 19XRV Service Updates

Chee Nee Bong

October 2012

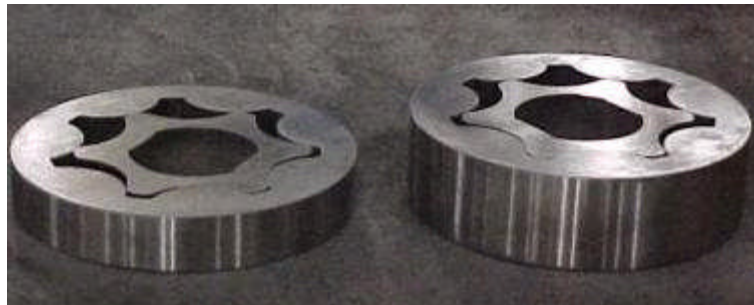
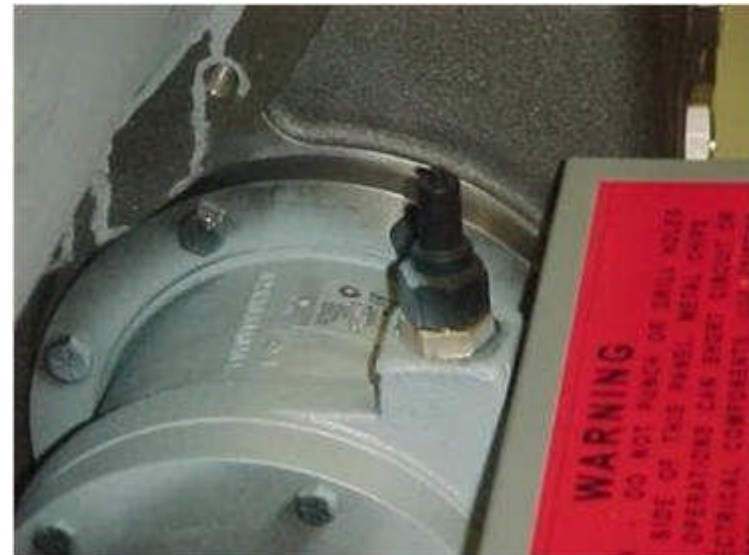
Starting above date, Gerotor pump replaced the vane pump

Less vibration on oil supply lines

Distinguished by external regulator

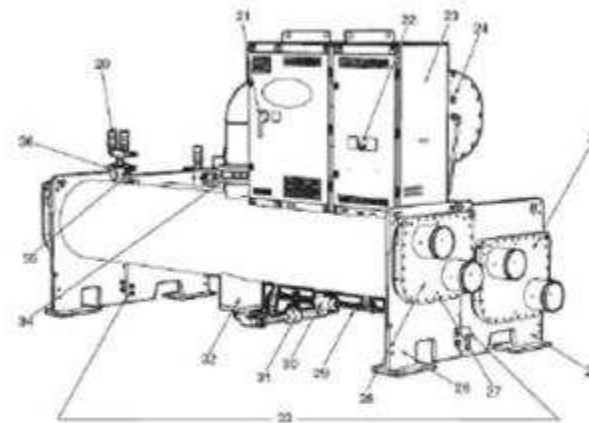
## Hot Gas Bypass Tube Rupture

**CAT Issue Description:** Ruptured tubing in HGBP piping.

**Root Cause Findings:** Trapped refrigerant in HGBP line can cause pressure increase leading to ruptured tubing.

**Corrective Action Plan (Field):** Eliminate HGBP isolation valve. Valve has been found to be redundant in current configuration.

**Corrective Action Plan (Factory):** Short term – Position HGBP isolation valve in open position before shipment. Long term - Eliminate HGBP isolation valve. Valve has been found to be redundant in current configuration.
