Flash Sheet: LIT-2009F26
Issue Date: December 9, 2009

Affects: E-Link Gateway Release 1.0
--

Subject: E-Link Gateway Software Patch 1

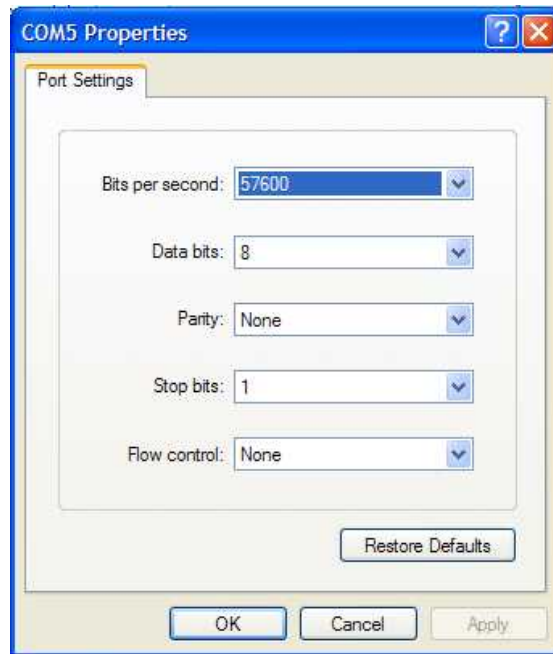
Figure 1: COM Properties

5. Connect the RS485 adaptor to Port 3 on the E-Link.
6. Start Windows HyperTerminal. Select the correct COM port for your adaptor, and configure the properties as shown in Figure 1 and Figure 2.

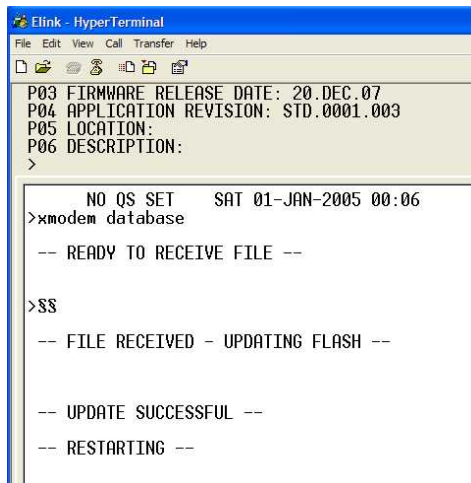
Figure 4: Successful Upload

13. Click Send. The new database uploads to the E-Link. When the upload completes, the E-Link responds with **UPDATE SUCCESSFUL**, and then restarts. See Figure 4.

```
Elink - HyperTerminal
File Edit View Call Transfer Help
P03 FIRMWARE RELEASE DATE: 20.DEC.07
P04 APPLICATION REVISION: STD.0001.003
P05 LOCATION:
P06 DESCRIPTION:
>
NO QS SET SAT 01-JAN-2005 00:06
>xmodem database
-- READY TO RECEIVE FILE --
>$$
-- FILE RECEIVED - UPDATING FLASH --
-- UPDATE SUCCESSFUL --
-- RESTARTING --
```
