Global Chiller

Service Manual

30GX Series 0, 1, 2 and 3, Air-Cooled Chillers
30HXA Series 0 and 3, Condenserless Chillers
30HXC Series 0 and 3, Water-Cooled Chillers

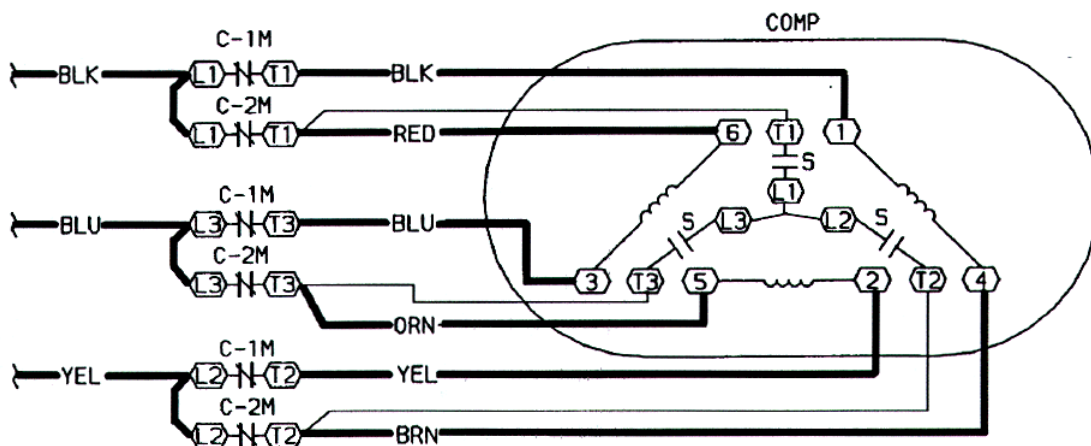
Figure 2 - Delta Operation

Approximately five (5) seconds after starting, the “S” contactor is opened. With the change to ComfortLink Compressor Protection Module Revision 26 software, the transition timing changed to 2.5 seconds. The motor is now disconnected from the power supply, yet continues to turn. The motor speed will slow during this transition. The motor should not slow to less than 80% of the operating speed. Within 49 milliseconds, the “2M” contactor is energized. With “1M” and “2M” energized, the motor is configured into a delta configuration.

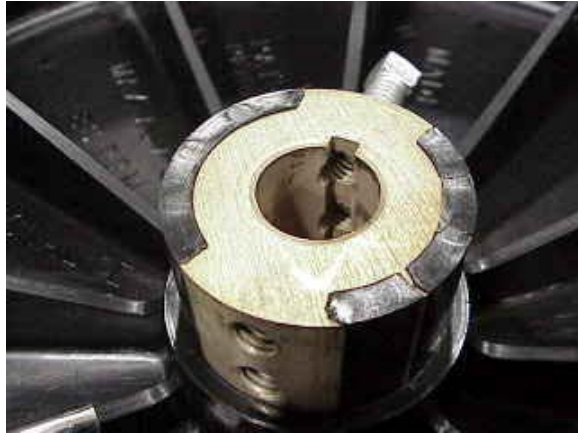
**Table 5 - Fan Hub
(Prior Serial Number 5200F)**

Beginning with serial numbers 5200F, the hub was redesigned to have pins to better capture the plastic to the hub. A spun-in washer was added to the hub to stop the fan from sliding down the shaft as shown in the figure below.

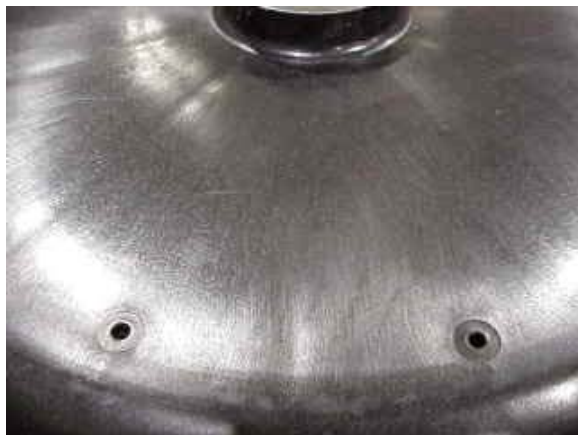
**Table 7 - Fan Drain
(Prior Serial Number 5200F)**

The fan cover was redesigned slightly to secure the cover better. Larger drain holes were molded into the fan as shown below. The view shown is from the under side of the fan.

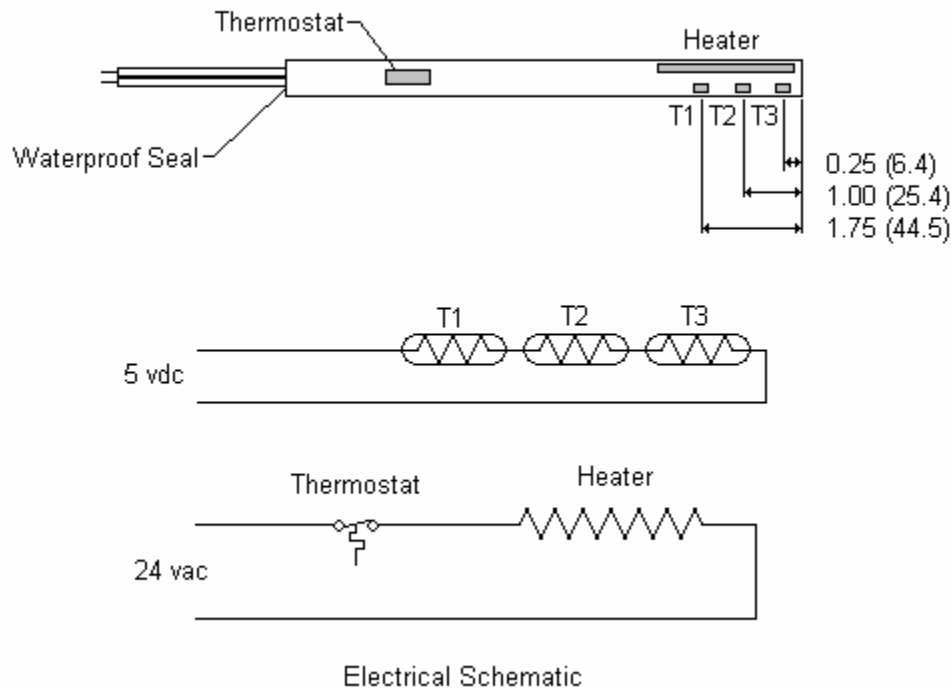
Figure 3 - Cooler Liquid Level Sensor

Cooler Liquid Level Sensor

This device provides the control system with an operating level of liquid refrigerant in the cooler. The device uses an 18-watt heater to heat three (3) 5 k Ω @ 77 °F (25 °C) thermistors wired in series. The thermostat is set to maintain the device at 110 °F \pm 2.8 °F (43.3 °C \pm 5.0 °C).
