Service Information

Equipment Affected: YCAV & YCIV Chillers

**LOW SUCTION PRESSURE AND HIGH
FLASH TANK FAULT TROUBLESHOOTING**

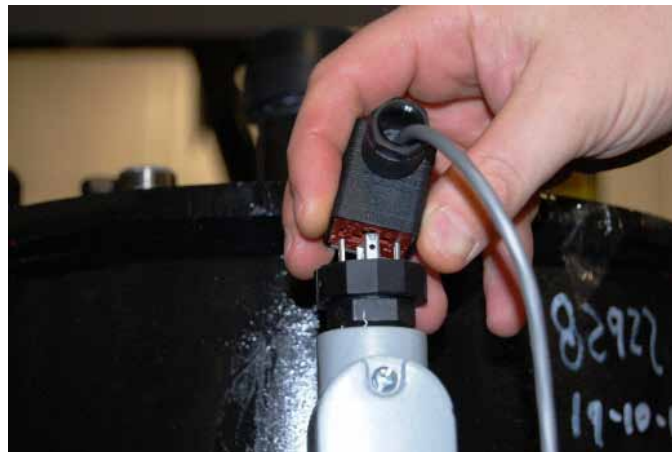
LD14652

Disconnect Power

1. Shut the chiller down and remove power. Unplug the DIN connector from the head of the level sensor.

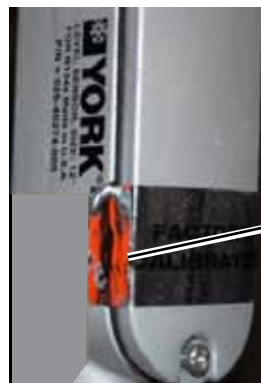
LD14653

Remove Sensor Head Cover

2. Cut the "Factory Calibrated" label along the joint of the sensor head cover to break the seal.

Cut the "Factory Calibrated" label along the joint of the sensor head cover to break the seal.

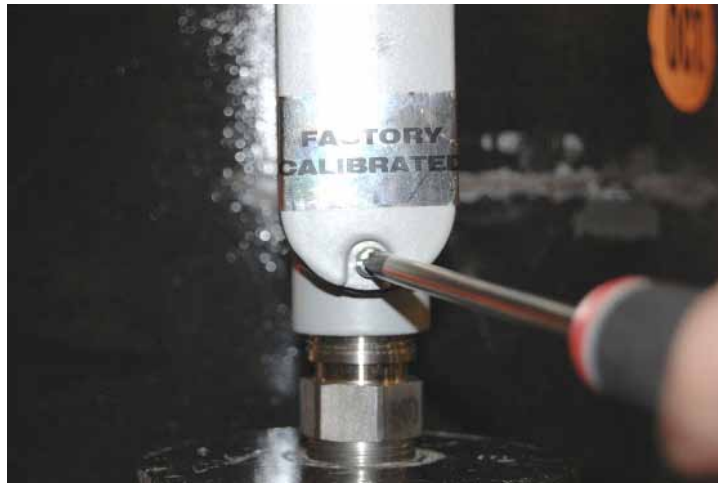
LD14654

3. Unscrew the (2) cover screws and remove the sensor cover using a #2 Phillips or flat blade screwdriver.

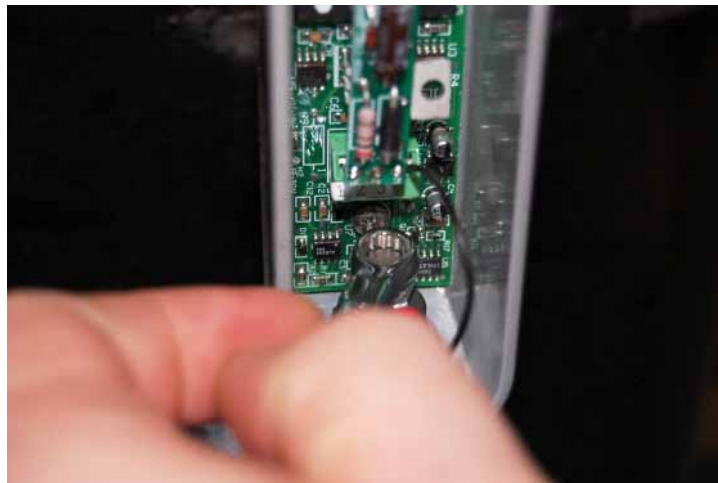
LD14655

Remove Probe Wire

4. Loosen the 1/4" hex probe screw using an open end wrench.

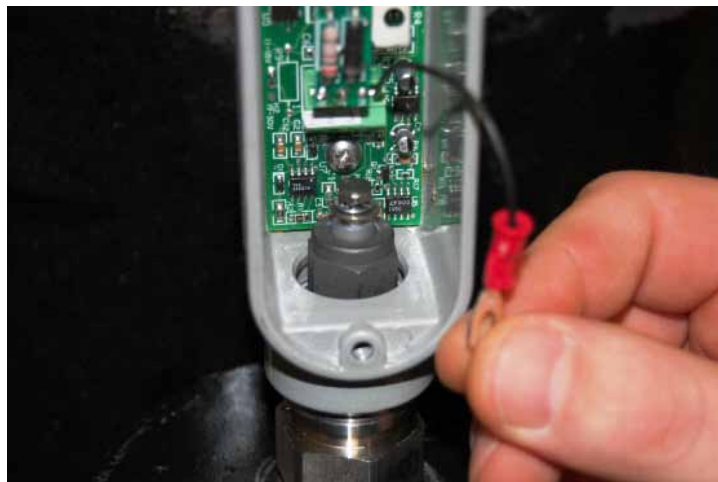
LD14656

5. Remove the probe connector terminal.

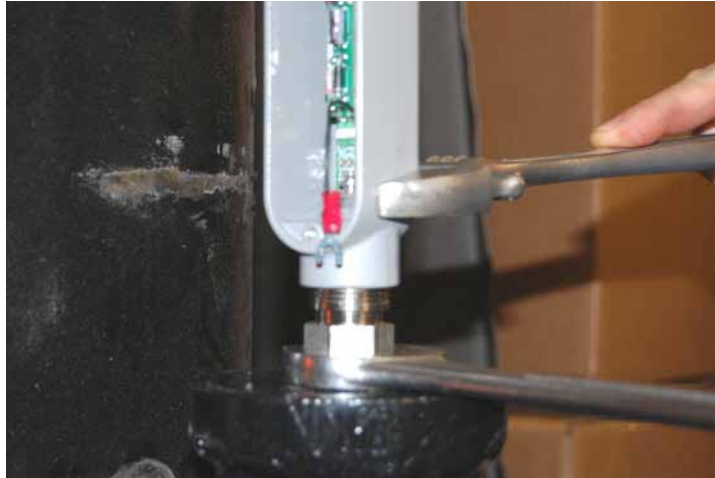
LD14657

Remove Sensor Head

6. Using a 1-1/16" wrench to hold the probe body hex nut, turn the sensor head with an adjustable wrench.

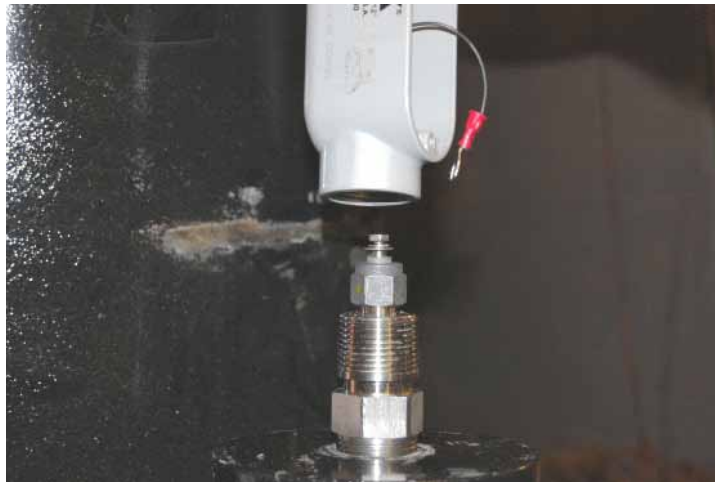
LD14658

7. Remove the sensor head.

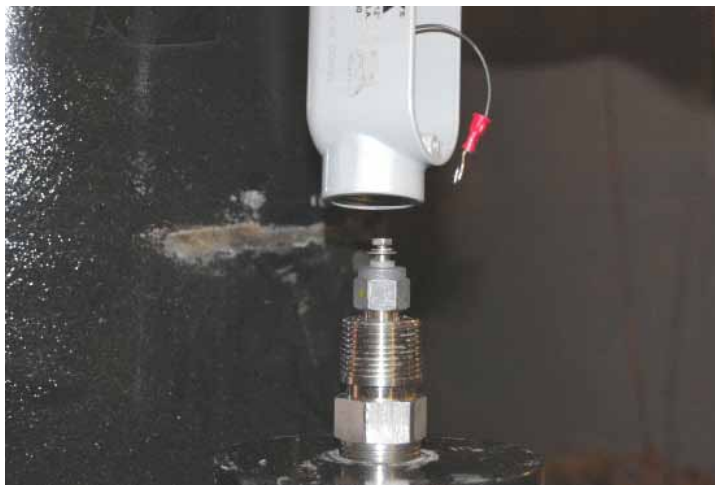
LD14658

Install New Head

8. Thread the replacement sensor head onto the probe by hand.

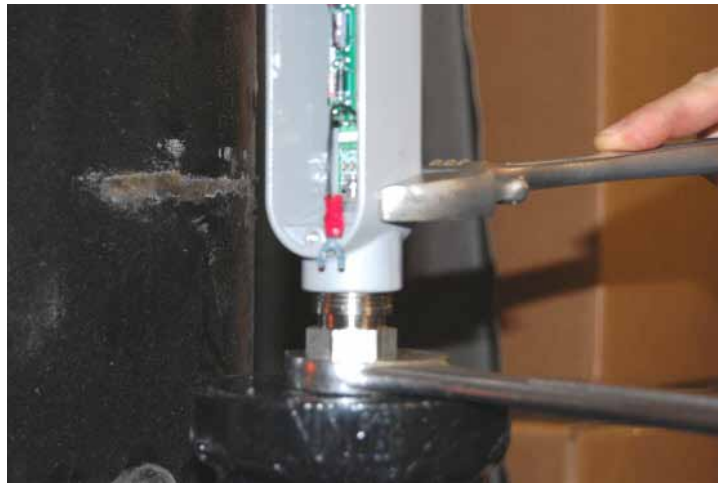
LD14657

9. Tighten the electronic head using a 1-1/16" wrench on the probe hex nut and the adjustable wrench on the head.

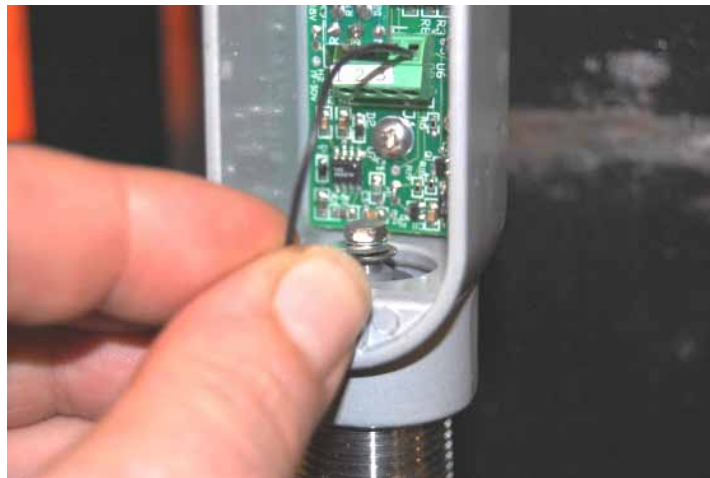
LD14661

Connect Probe Wire & DIN Connector

10. Reconnect the probe wire terminal to the probe by inserting the connector between the washers.

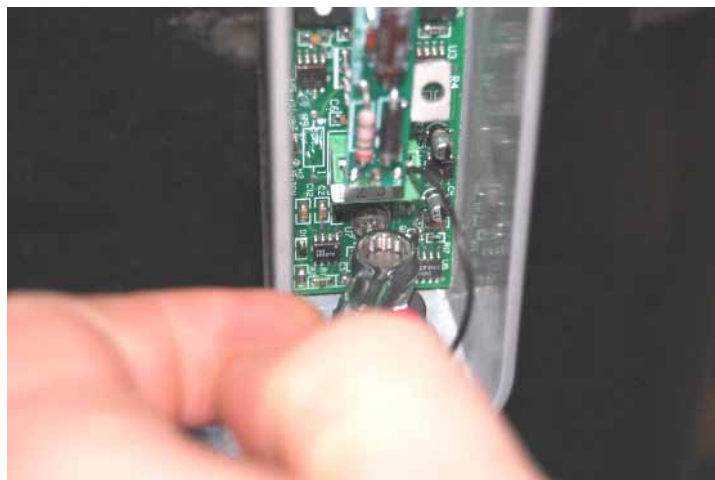
LD14662

11. Tighten using a 1/4" open end wrench.

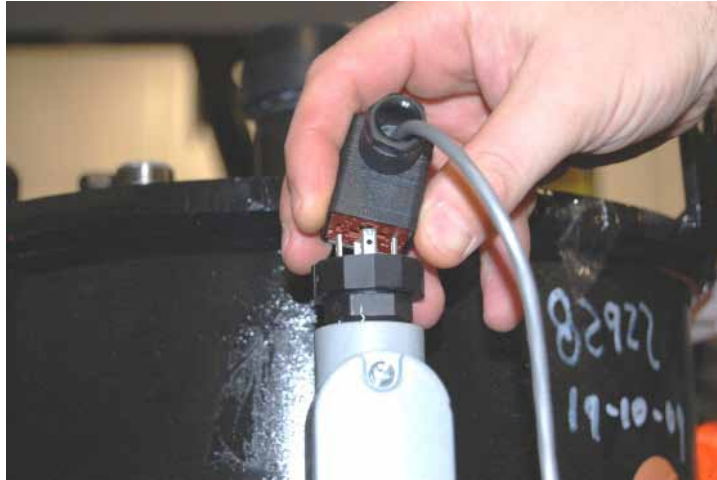
LD14663

12. Reconnect the DIN Connector.

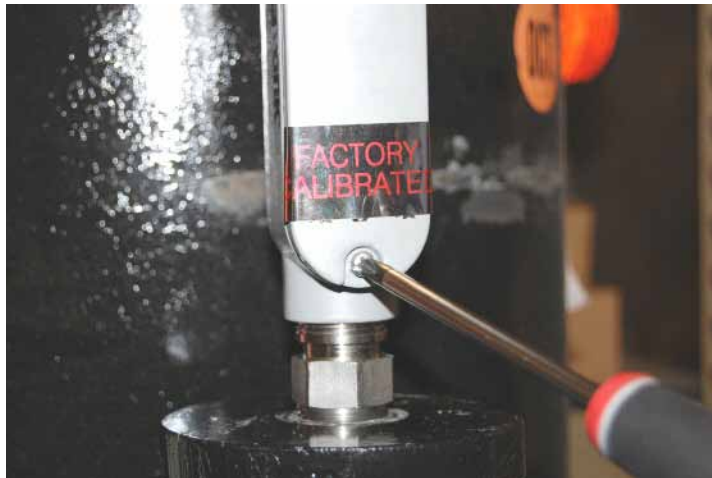
LD14664

Install J-box Cover

13. Install the electronic head cover using a #2 Phillips or flat blade screwdriver.

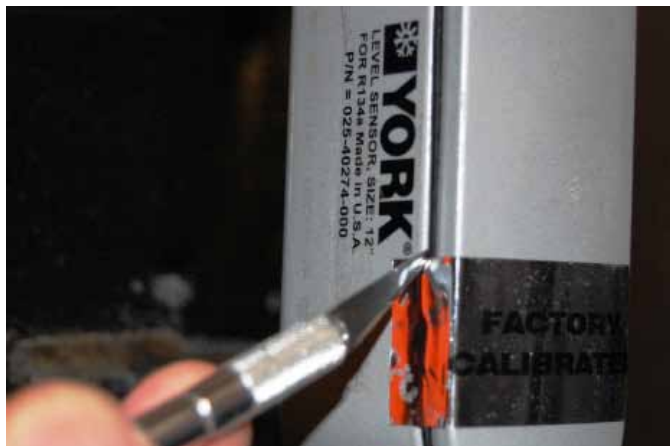
LD14653

1. Use a utility knife and slit the “Factory Calibrated” label along the joint of the sensor cover and head. Unscrew the two cover screws using a #2 Philips screwdriver. Remove the sensor cover.

SLIT LABEL

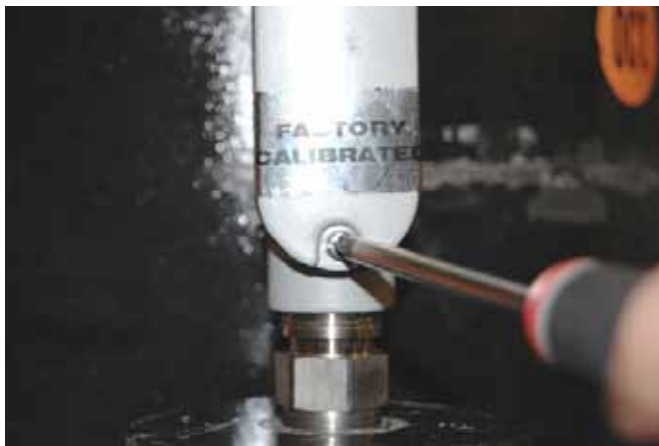
LD14654

REMOVE SCREWS

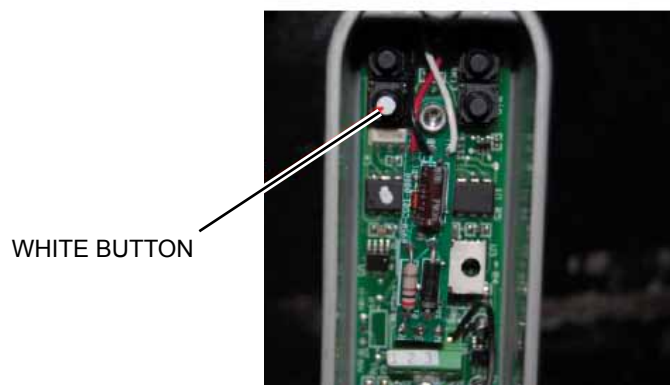
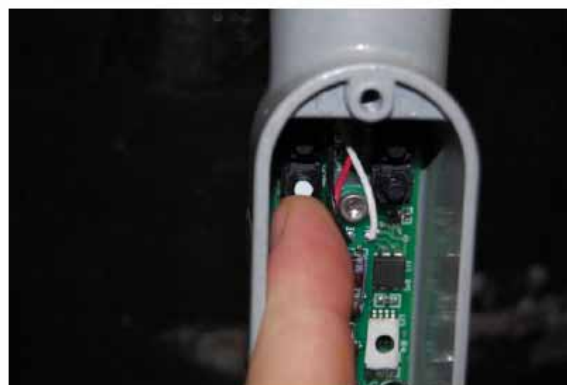
LD15443

Although some sensor electronics may be difficult to view directly while in a chiller, orient yourself as needed to view the electronics in the sensor head as if you are directly facing it.

WHITE BUTTON

PRESS BUTTON ONCE
