INSTALLATION, OPERATION, & MAINTENANCE OF APOLLO BARSTOCK VALVES

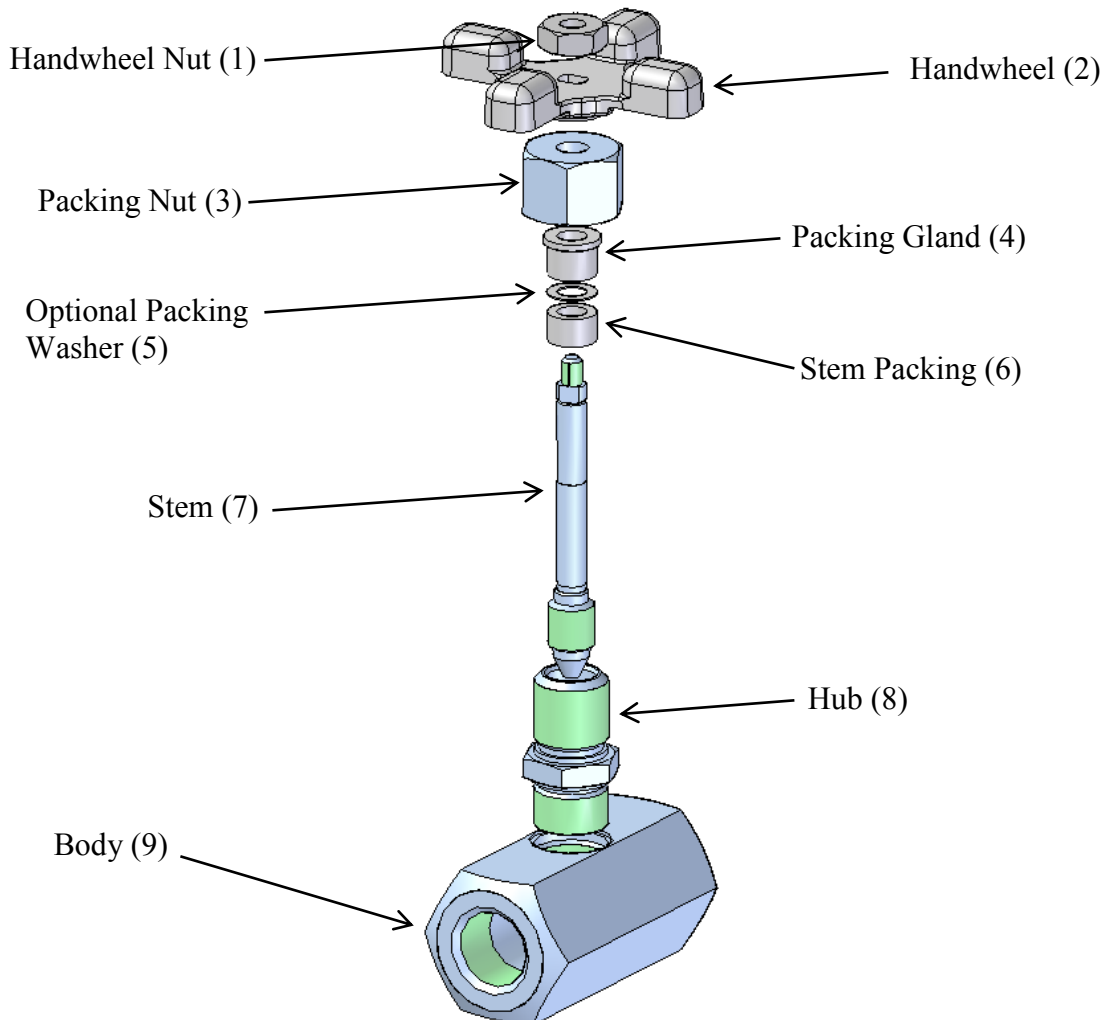
1. Remove the handwheel or handle nut (1), handwheel or handle (2), packing nut (3), and packing gland (4) and packing washer (5), if applicable.
2. Remove the old stem packing (6). Care should be taken not to scratch or damage the stem or stuffing box.
3. Clean and inspect the stem, stuffing box, and gland. Parts should be replaced if any heavy scratches, nicks, or corrosion are found.
4. Install the new stem packing.
5. Replace the packing washer (5), if applicable, the packing gland (4), packing nut (3), handwheel or handle (2), and handwheel or handle nut (1).
6. Tighten the packing nut until the packing is lightly compressed. Cycle the valve several times.
7. If slight stem leakage occurs after the system is pressurized, continue tightening the packing nut in quarter-turn increments until the leakage stops.
